# AT-10 WICHITA

Cadet Air Corps Museum AT-10 Wichita Restoration

by Chuck Cravens

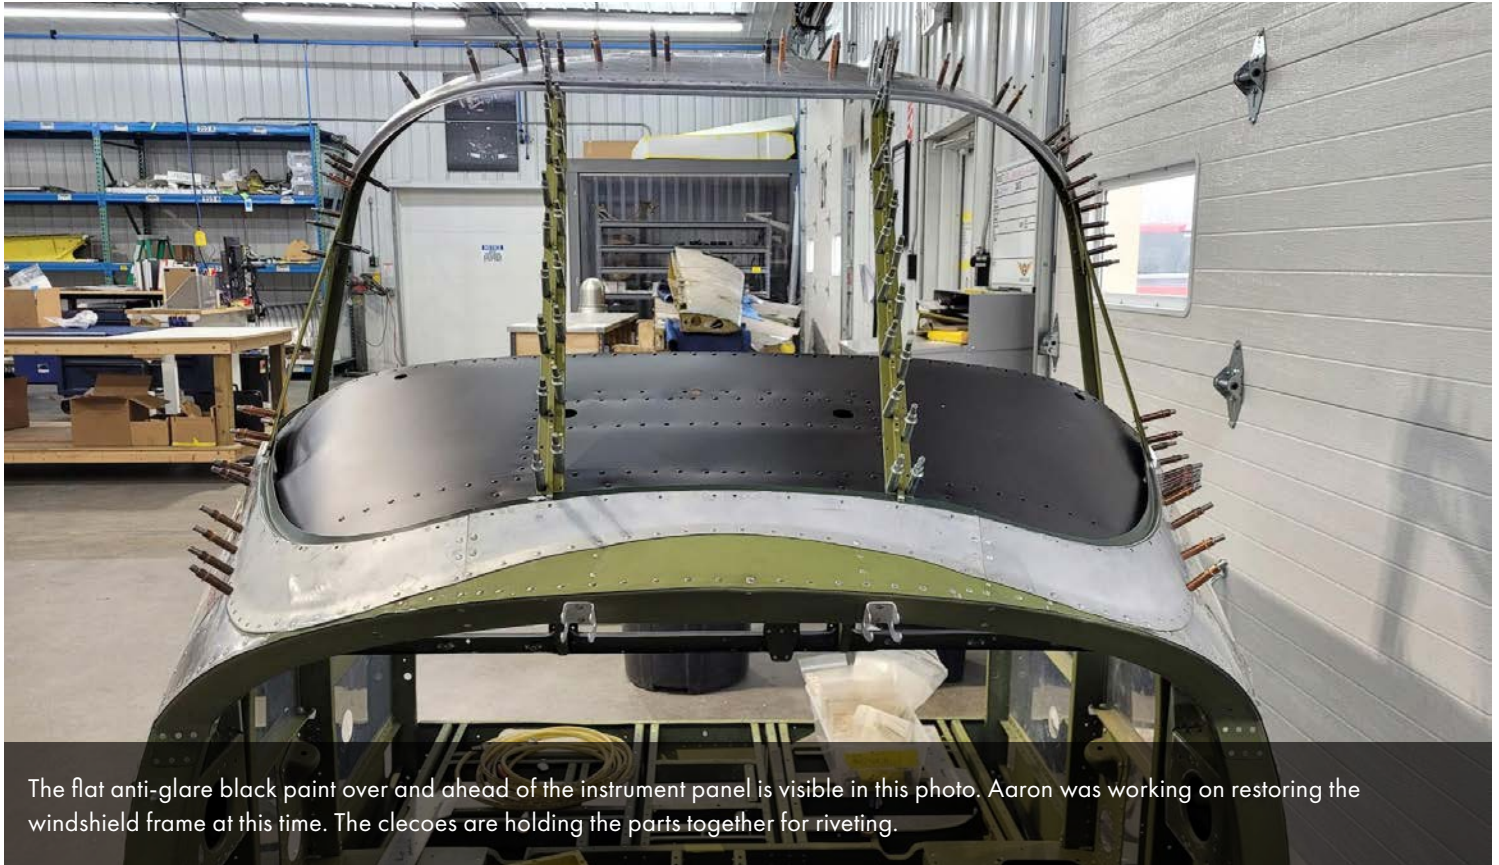
The flat anti-glare black paint over and ahead of the instrument panel is visible in this photo. Aaron was working on restoring the windshield frame at this time. The clecoes are holding the parts together for riveting.

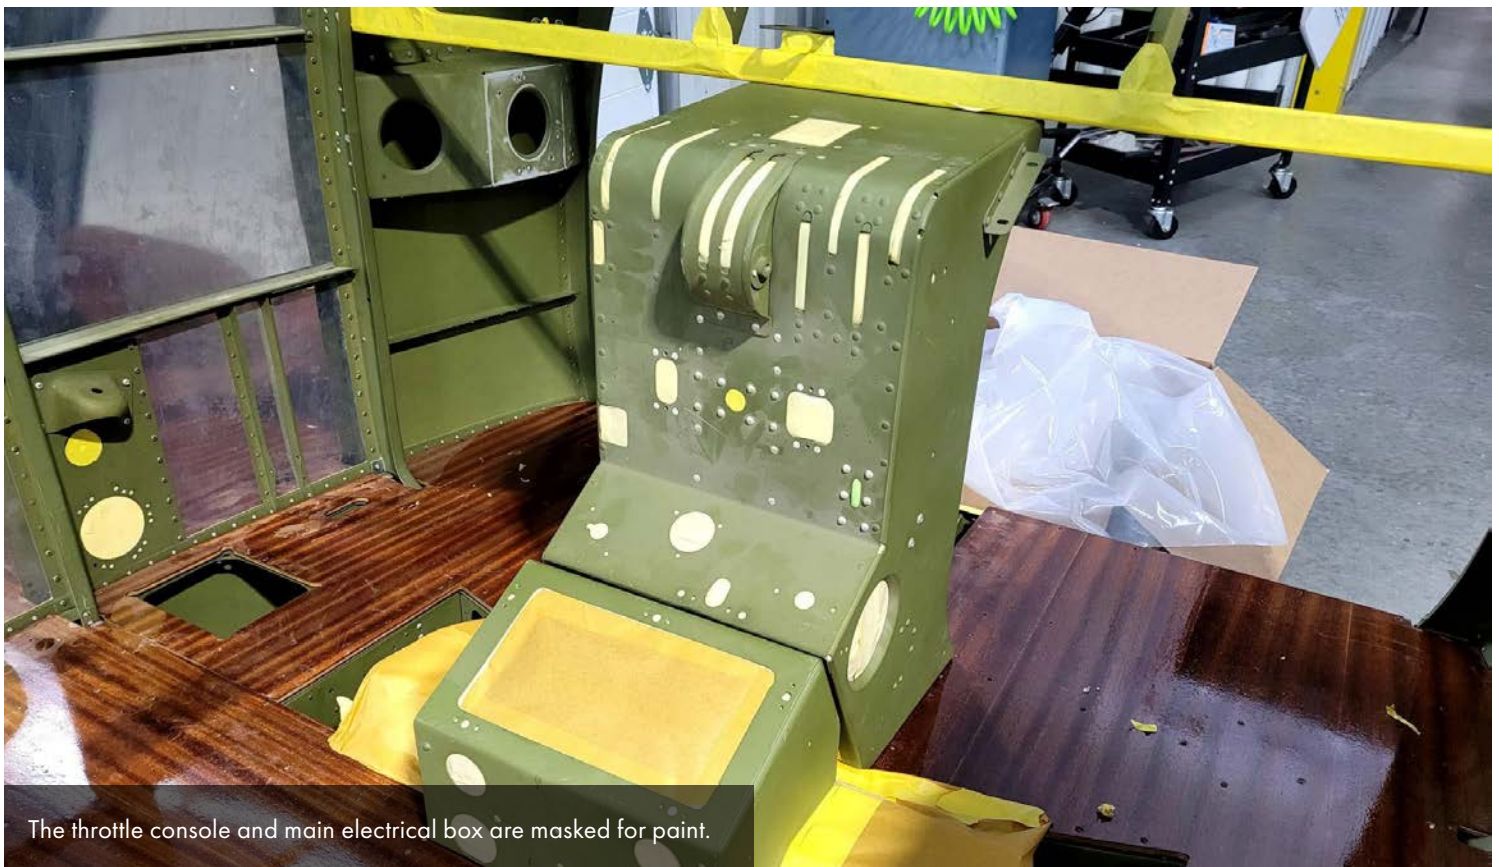
The throttle console and main electrical box are masked for paint.

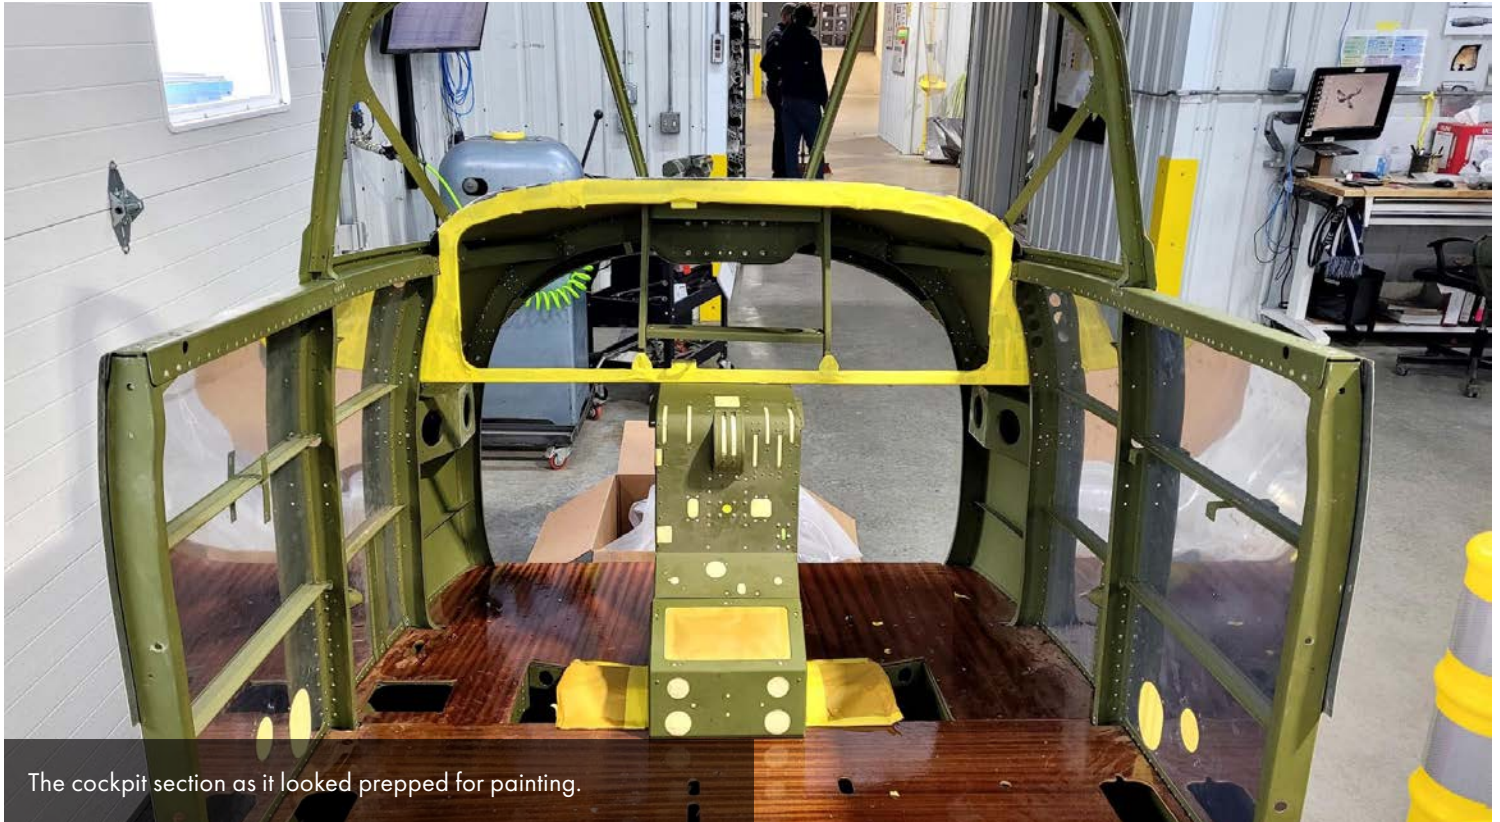
The cockpit section as it looked prepped for painting.

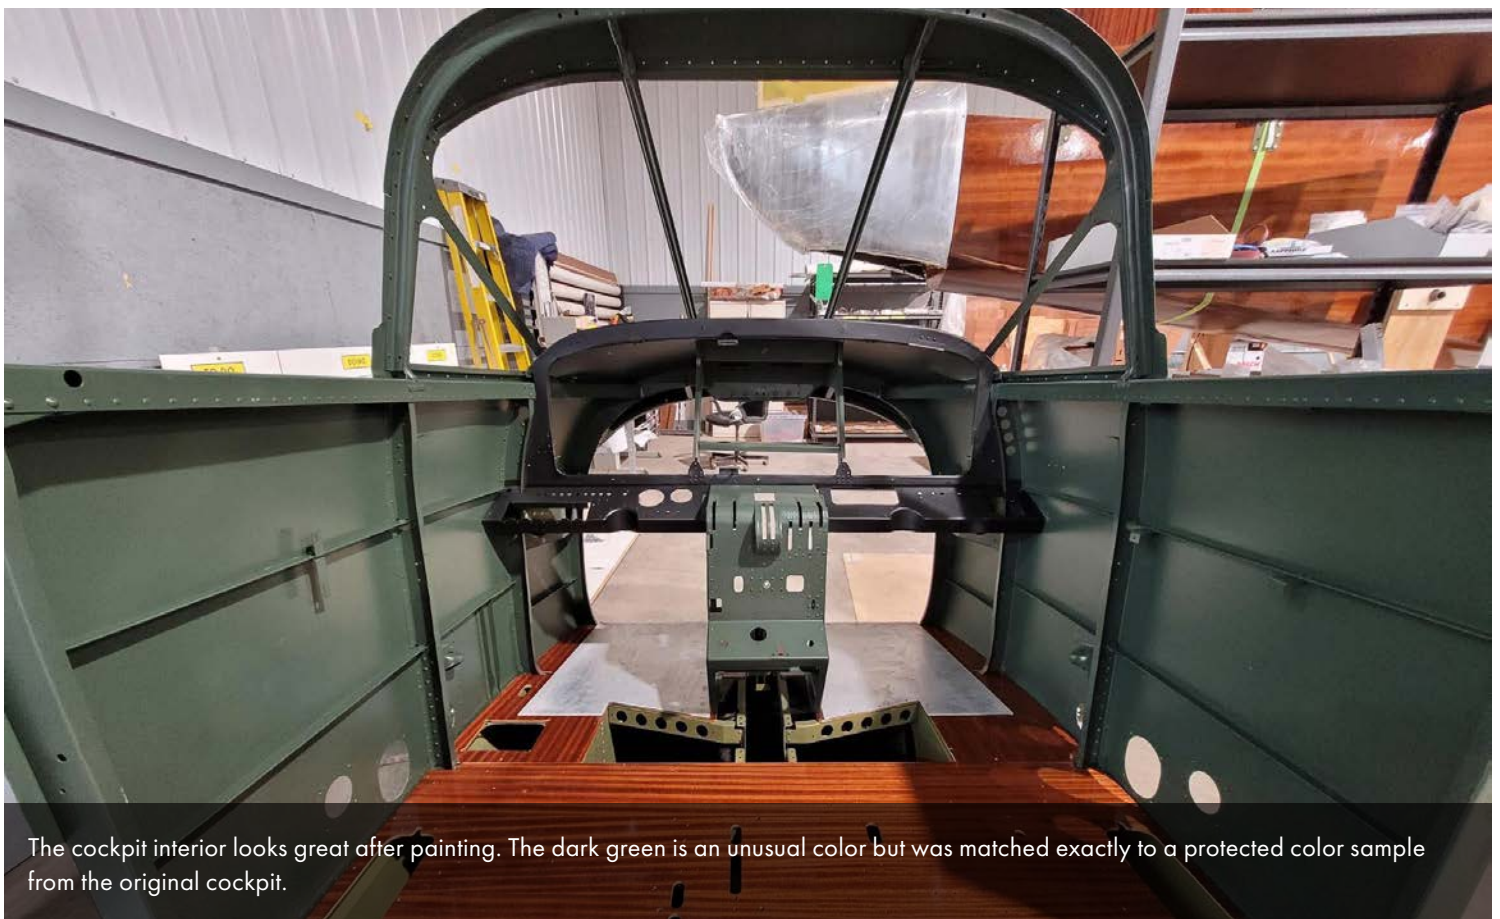
The cockpit interior looks great after painting. The dark green is an unusual color but was matched exactly to a protected color sample from the original cockpit.

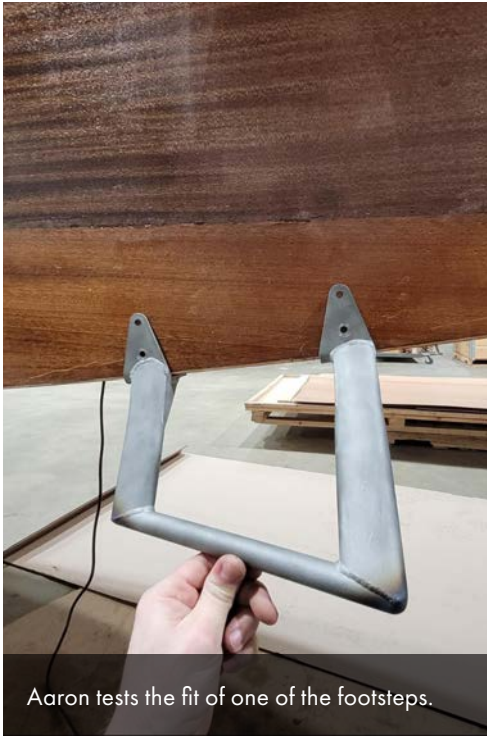
Aaron tests the fit of one of the footsteps.

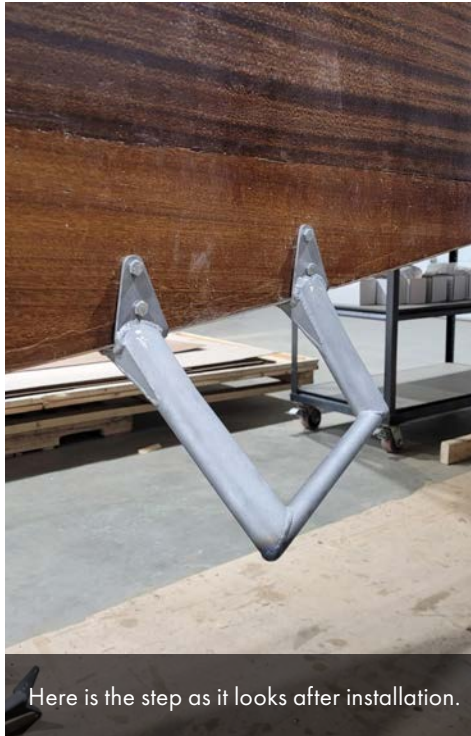
Here is the step as it looks after installation.

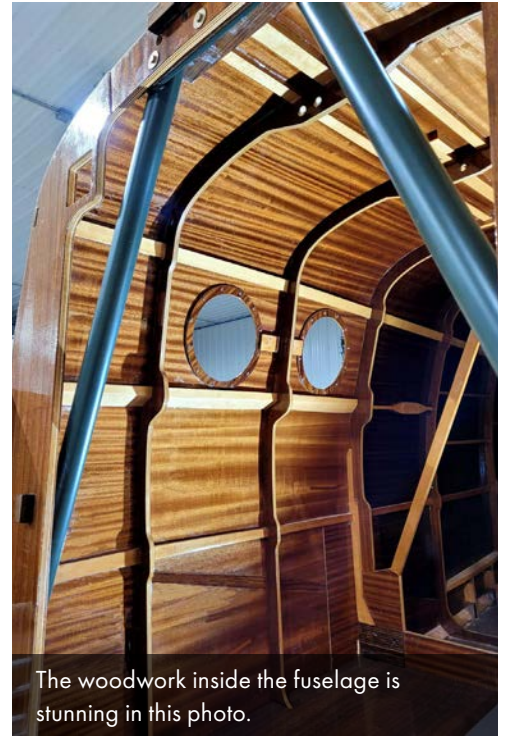
The woodwork inside the fuselage is stunning in this photo.

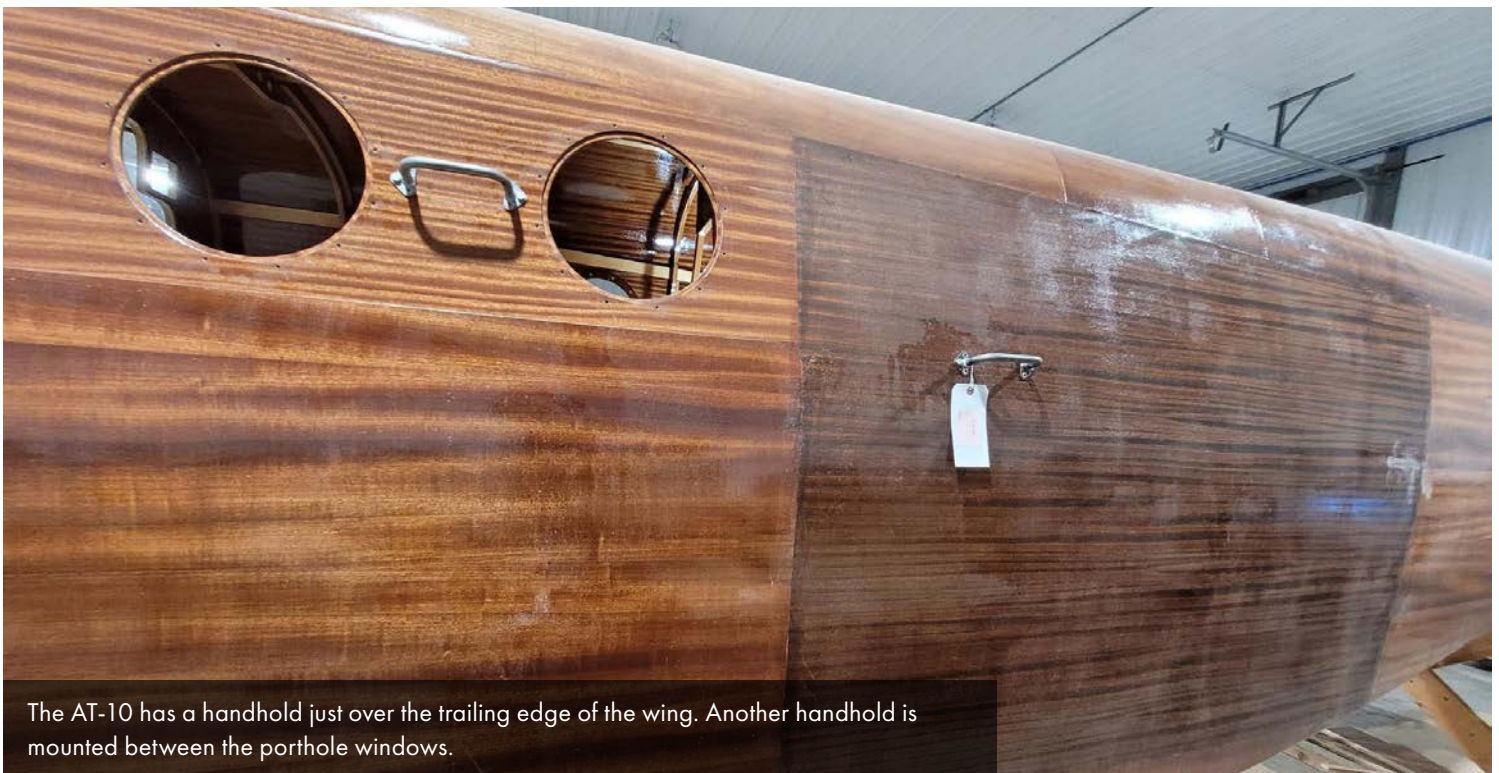
The AT-10 has a handhold just over the trailing edge of the wing. Another handhold is mounted between the porthole windows.

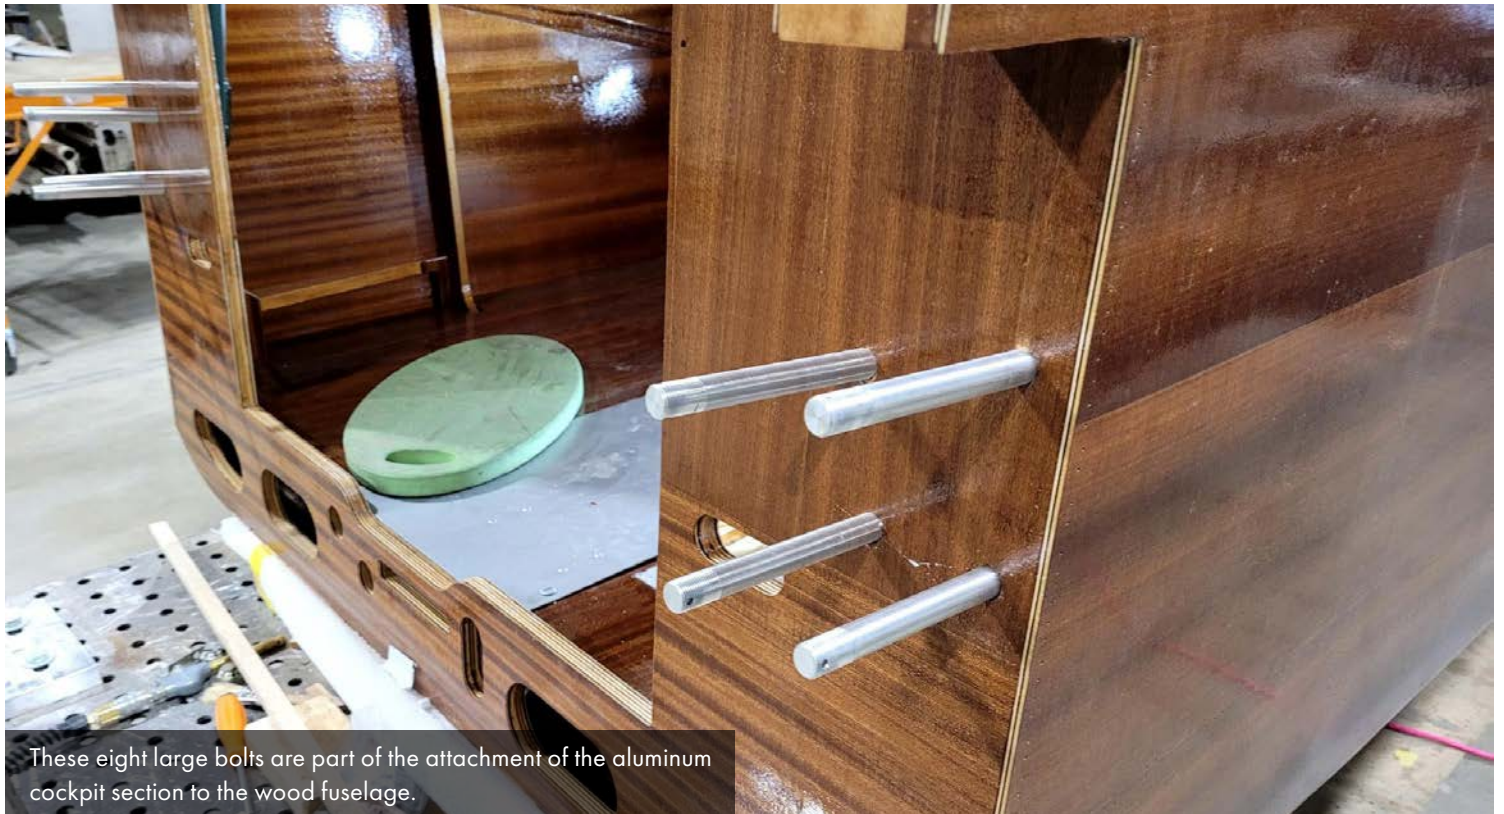
These eight large bolts are part of the attachment of the aluminum cockpit section to the wood fuselage.

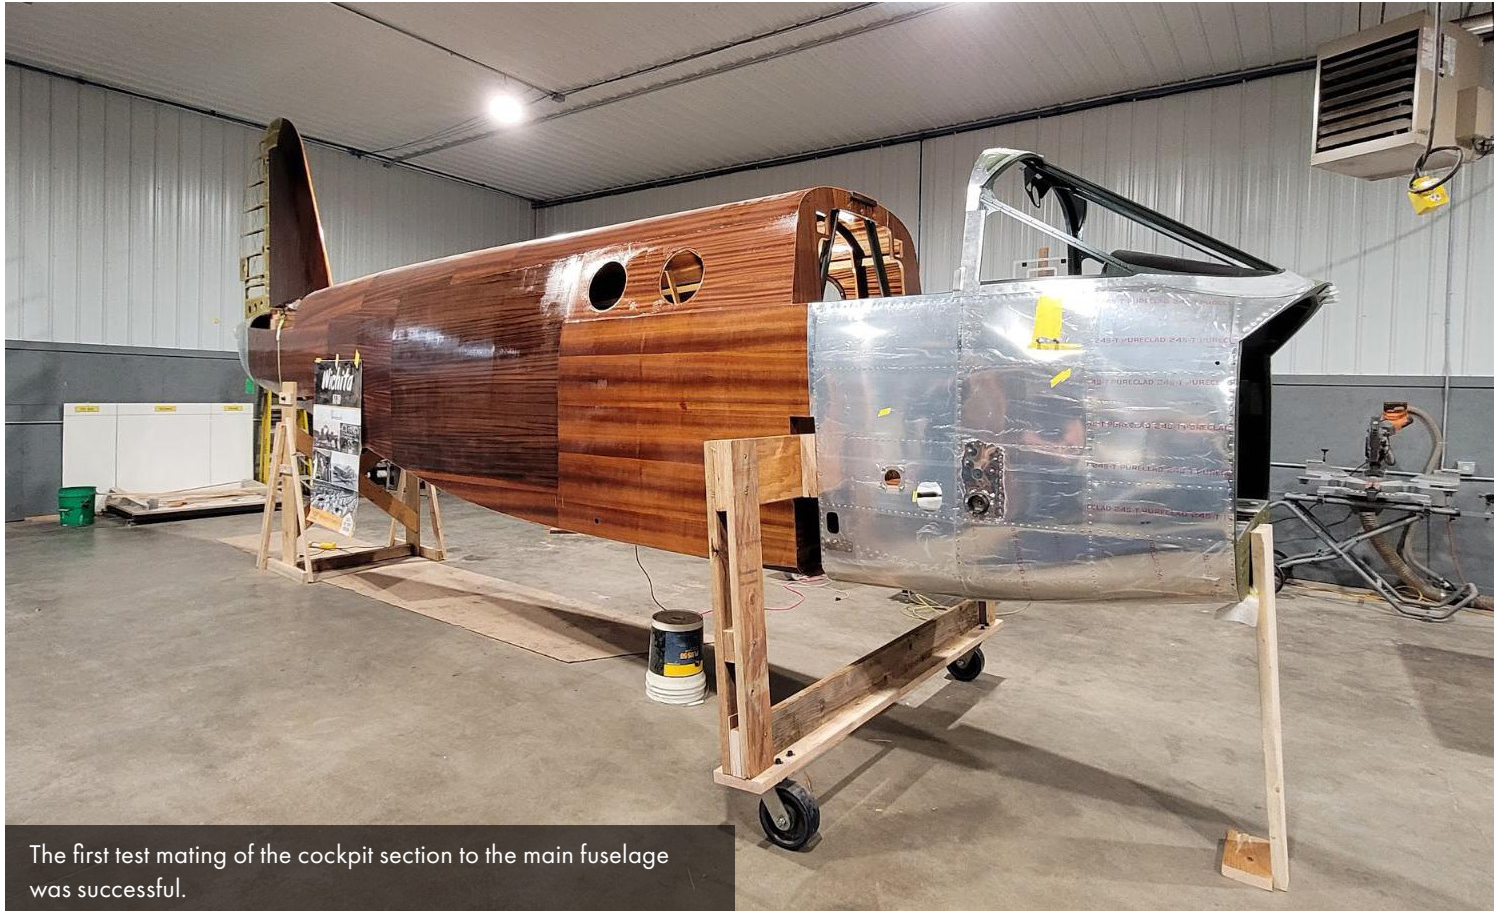
The first test mating of the cockpit section to the main fuselage was successful.

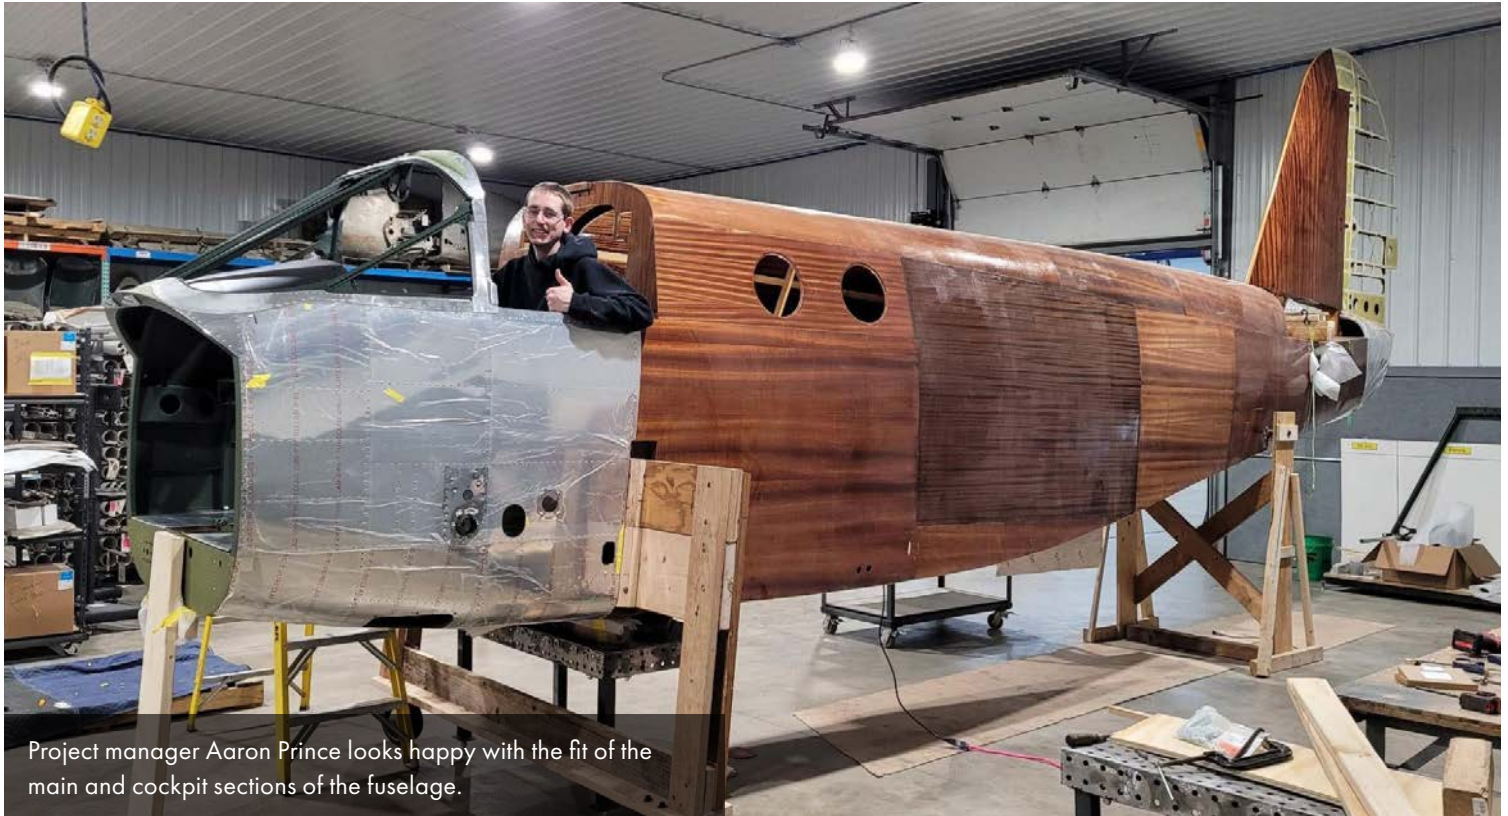
Project manager Aaron Prince looks happy with the fit of the main and cockpit sections of the fuselage.

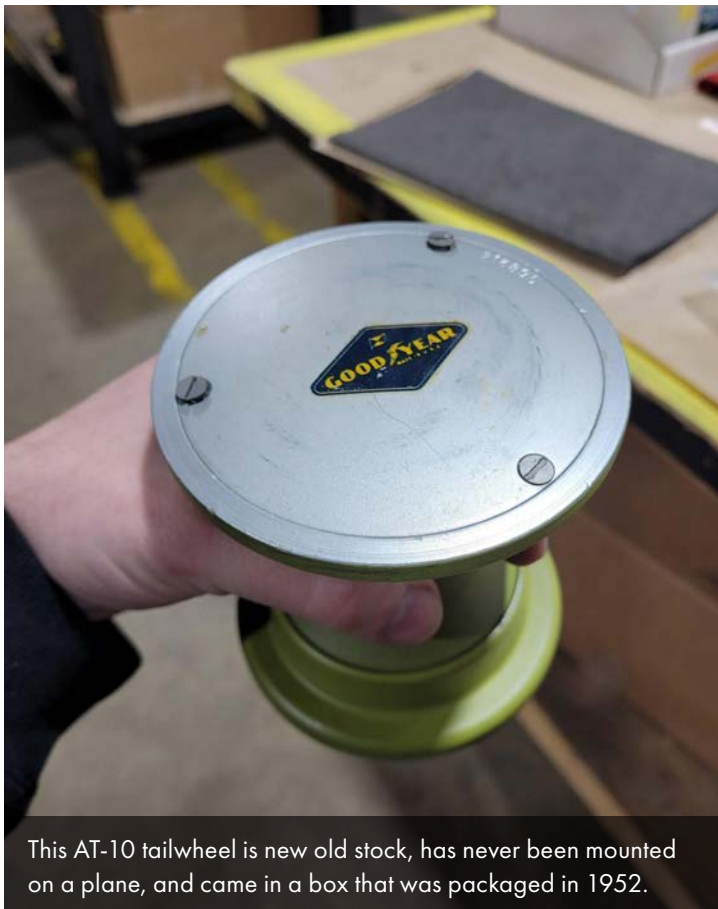
This AT-10 tailwheel is new old stock, has never been mounted on a plane, and came in a box that was packaged in 1952.

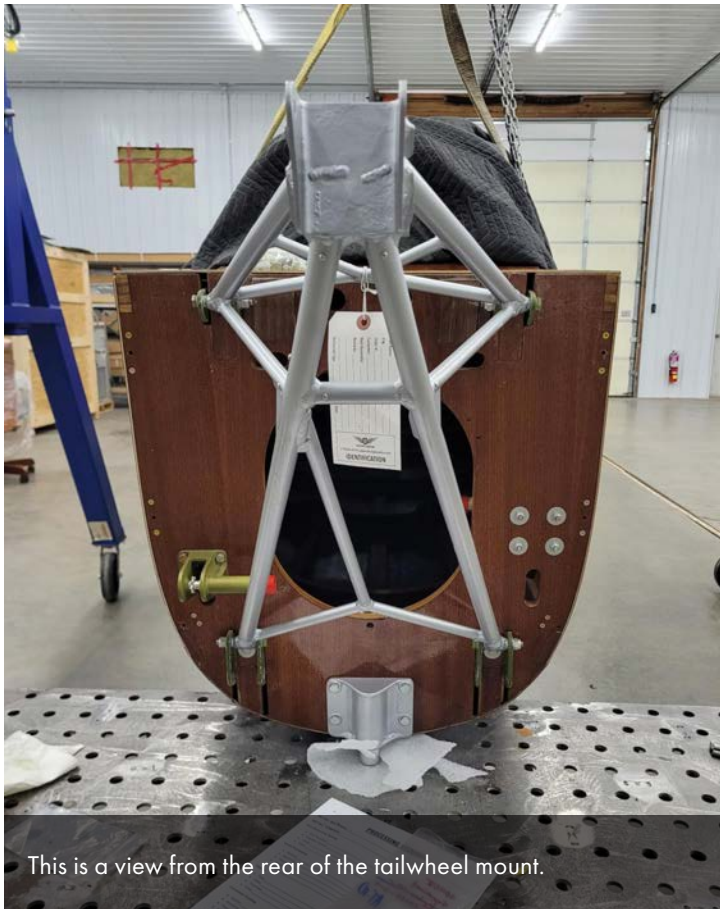
This is a view from the rear of the tailwheel mount.

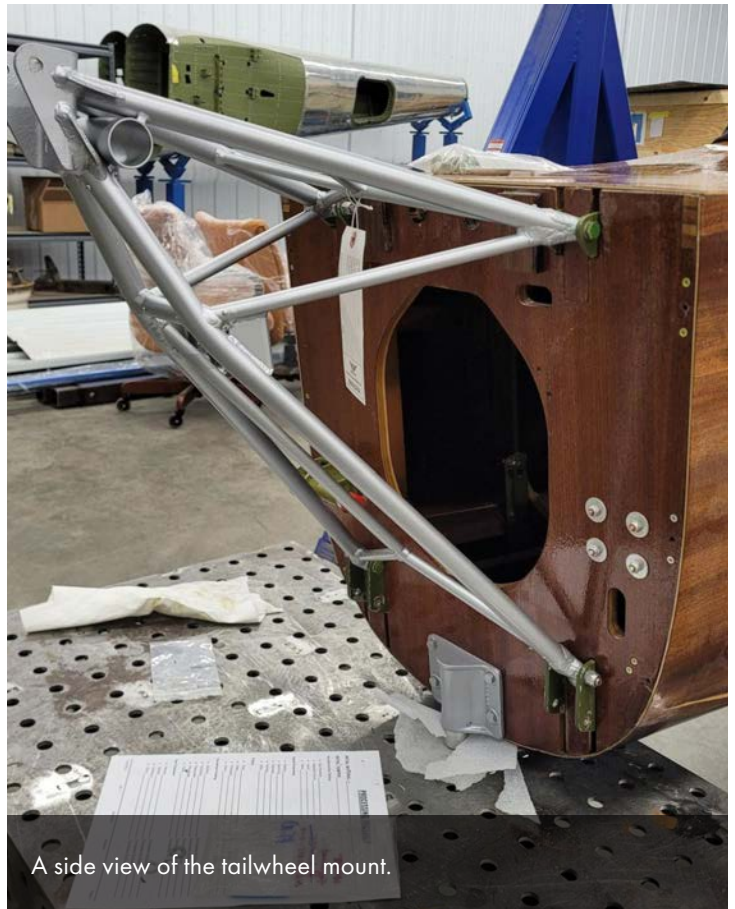
A side view of the tailwheel mount.

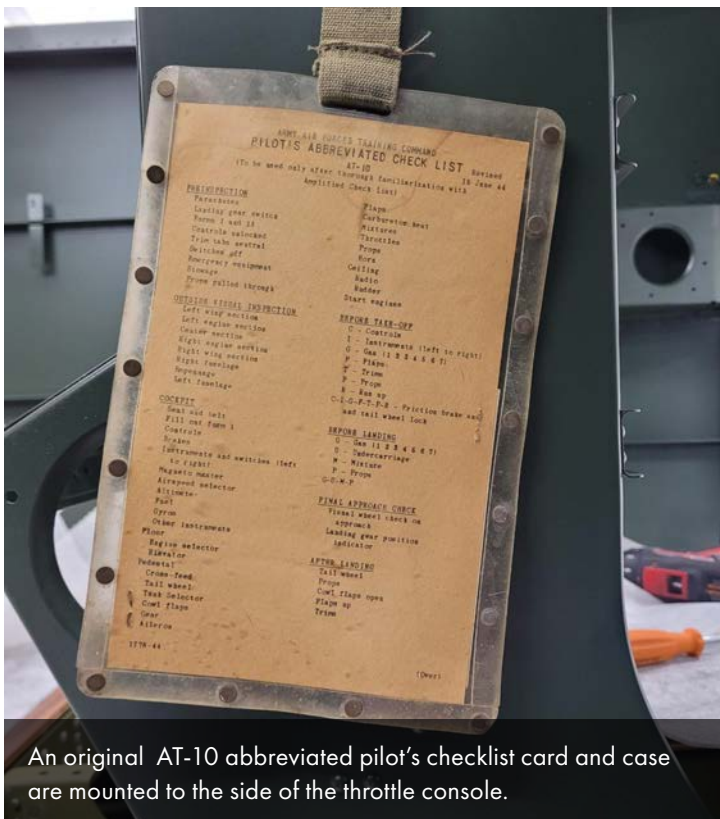
An original AT-10 abbreviated pilot's checklist card and case are mounted to the side of the throttle console.

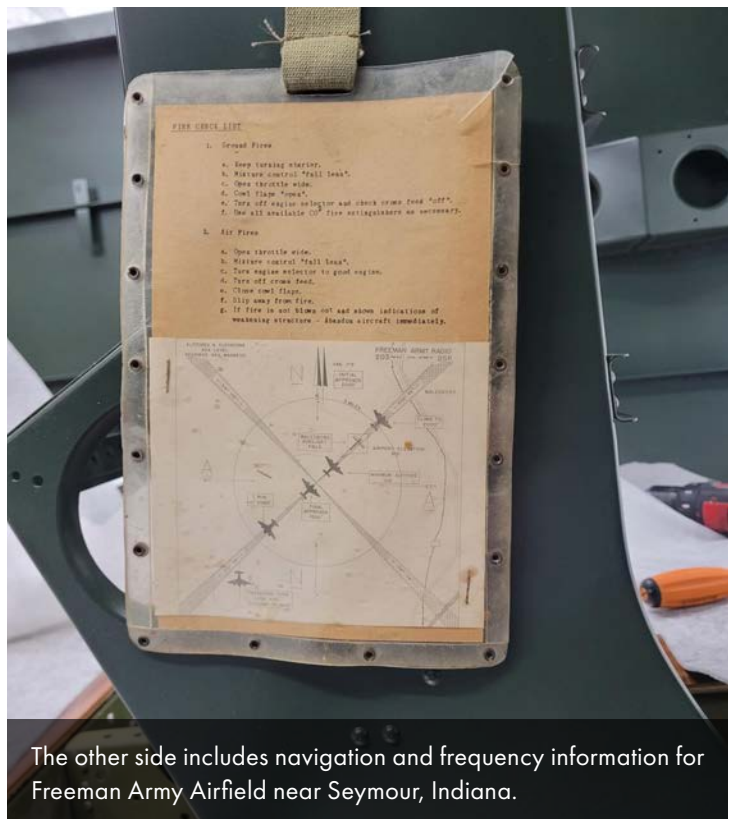
The other side includes navigation and frequency information for Freeman Army Airfield near Seymour, Indiana.

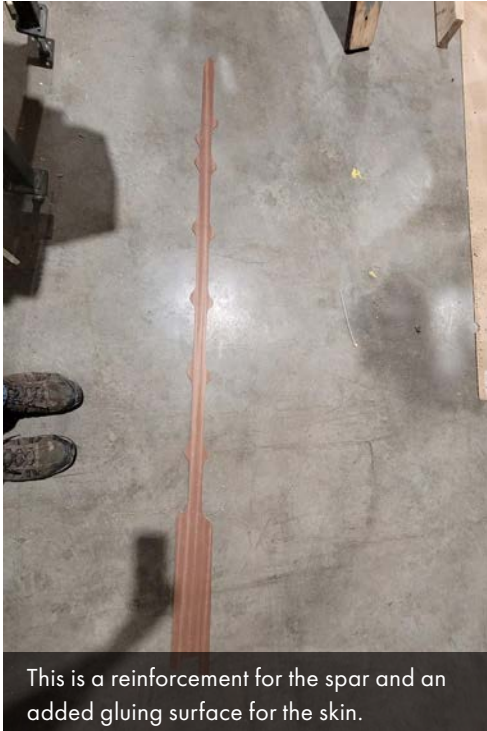
This is a reinforcement for the spar and an added gluing surface for the skin.

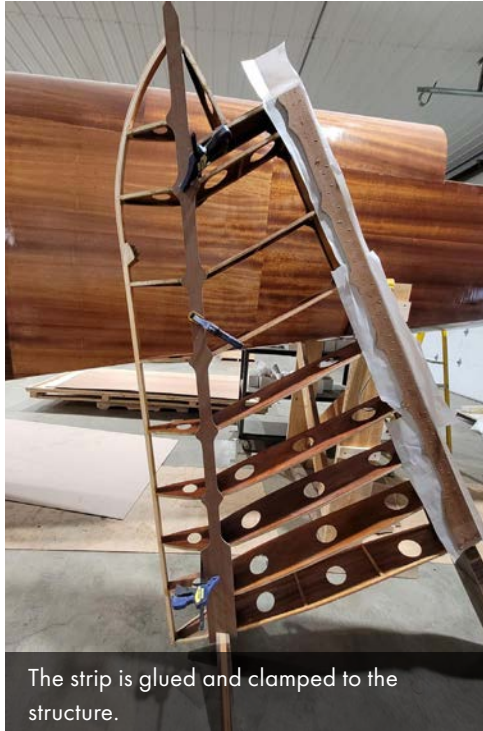
The strip is glued and clamped to the structure.

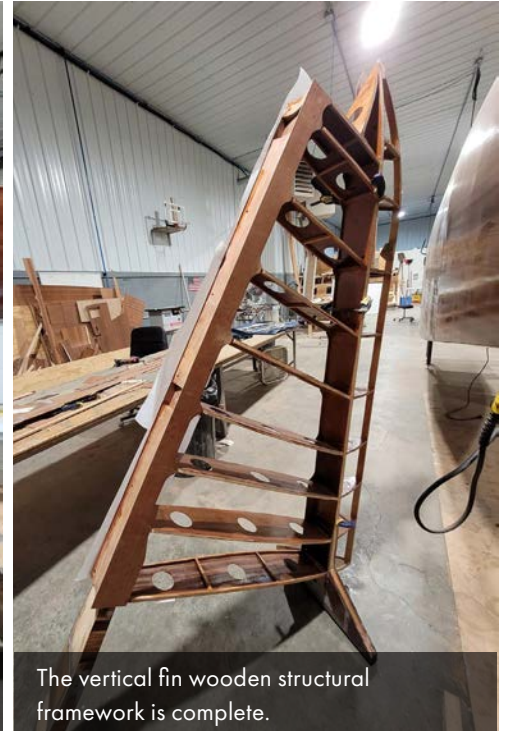
The vertical fin wooden structural framework is complete.

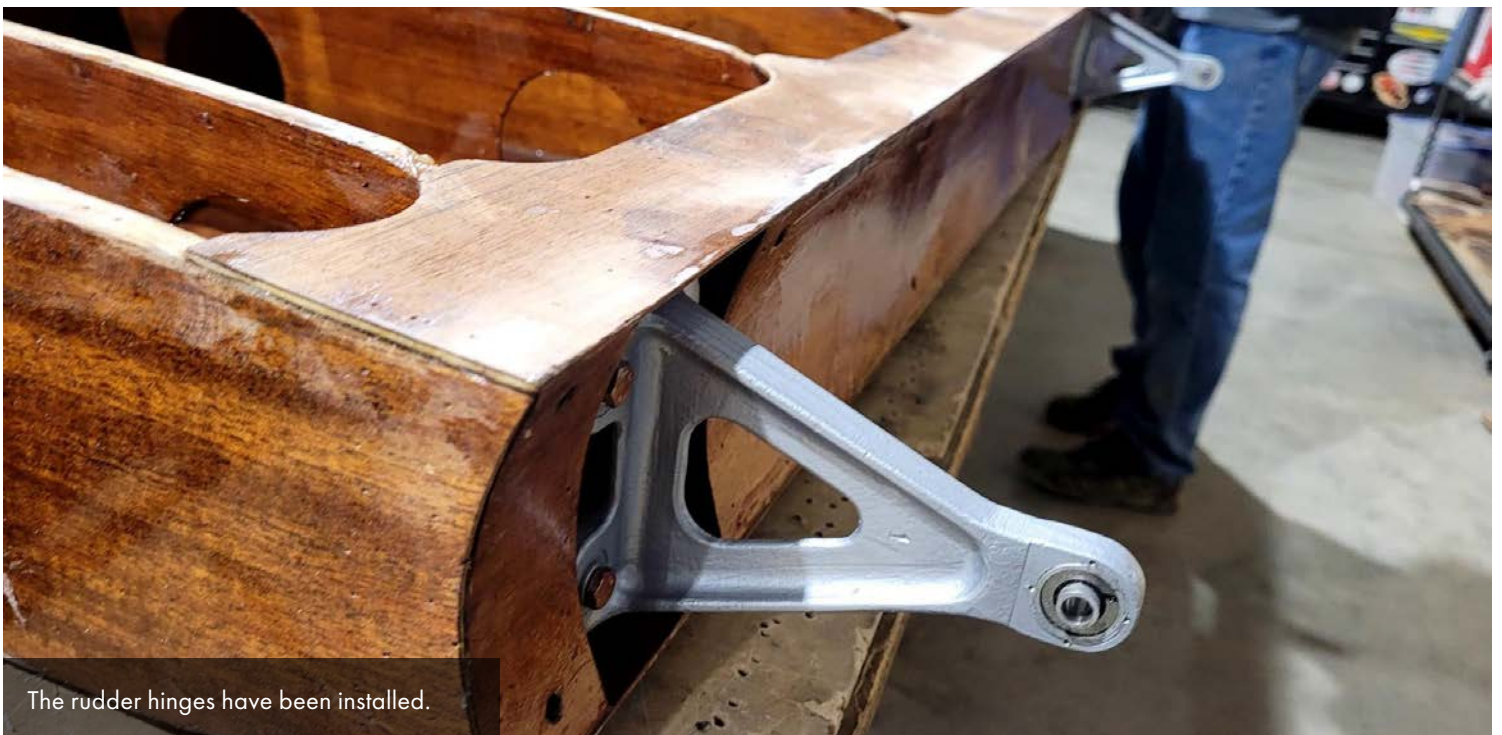
The rudder hinges have been installed.

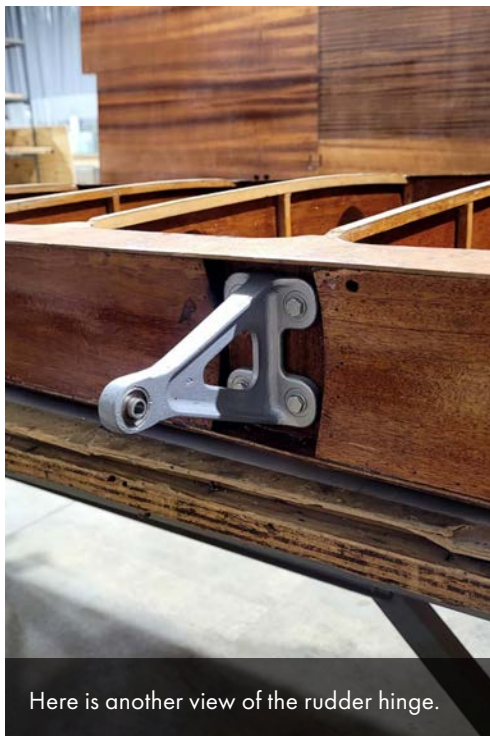
Here is another view of the rudder hinge.

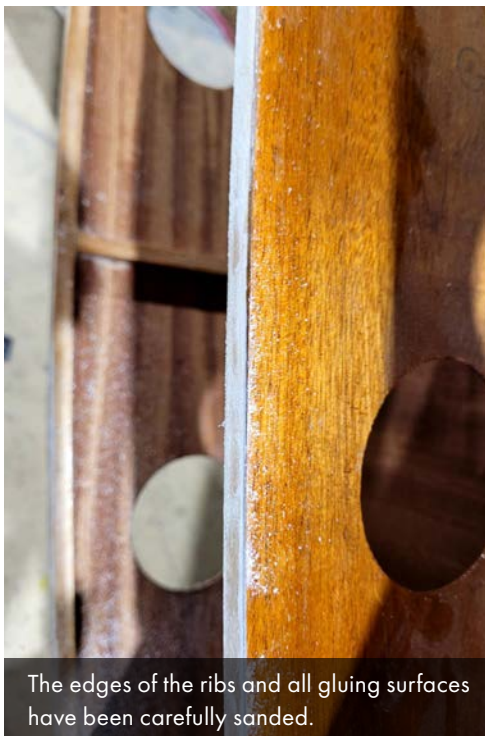
The edges of the ribs and all gluing surfaces have been carefully sanded.

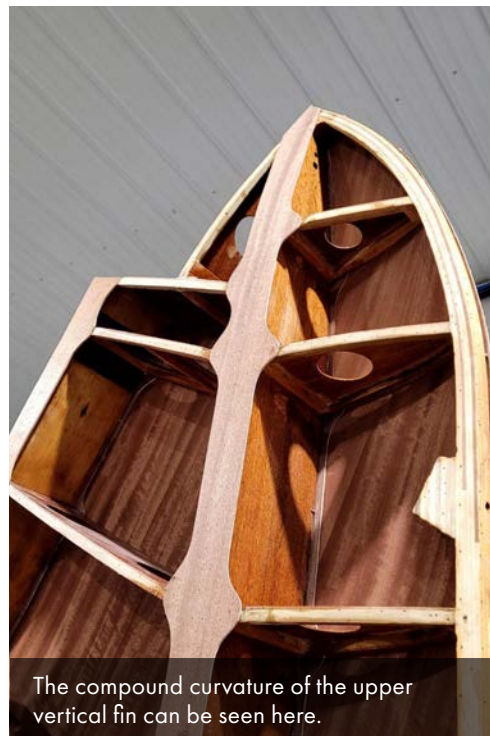
The compound curvature of the upper vertical fin can be seen here.

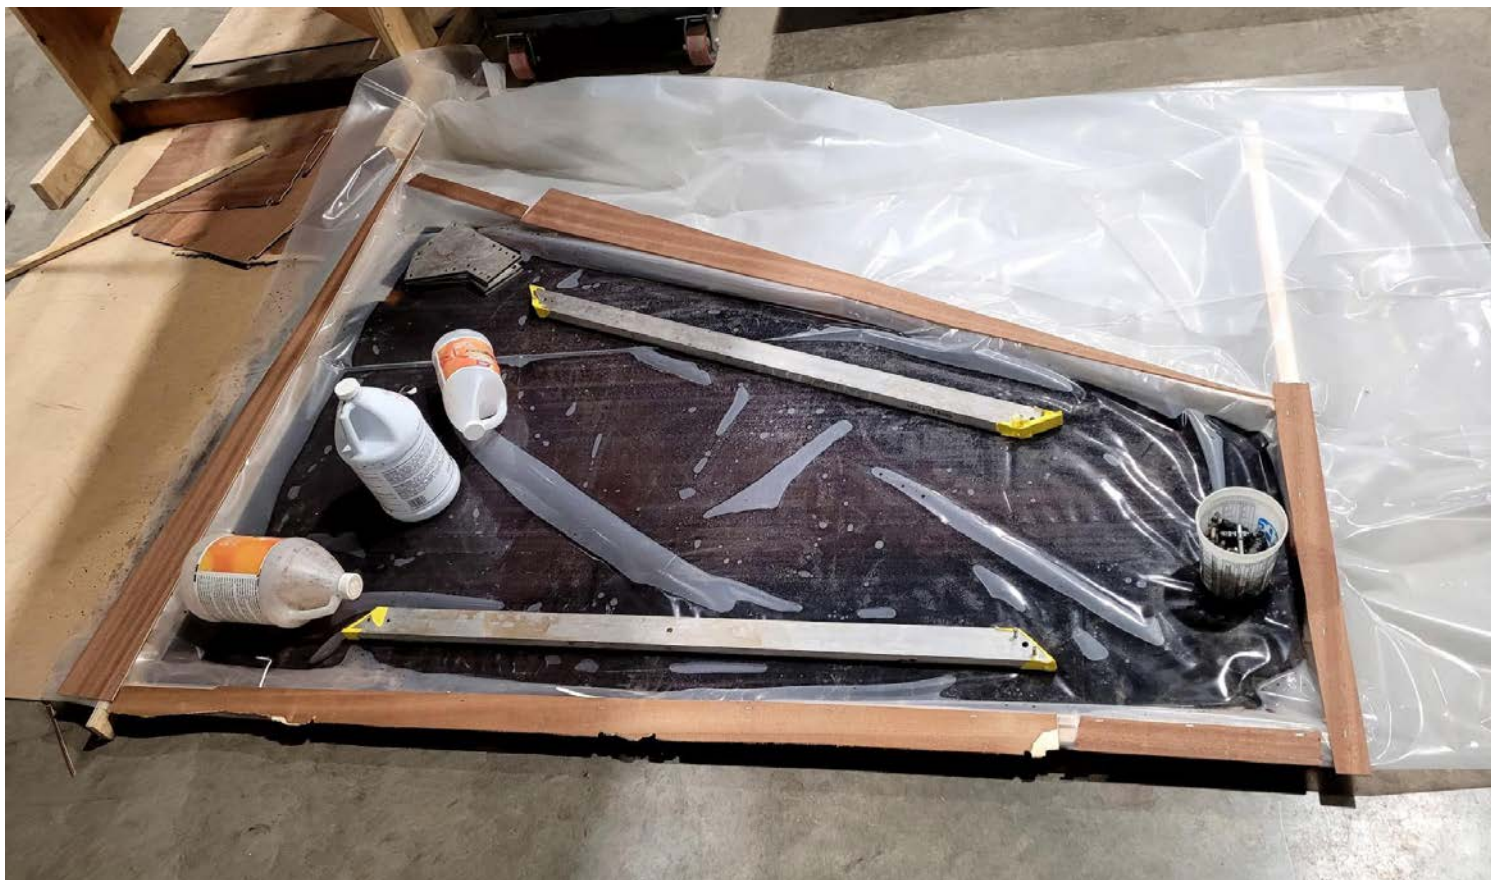
A skin section is soaked in ammonia and water to make it bendable for forming over curved sections.

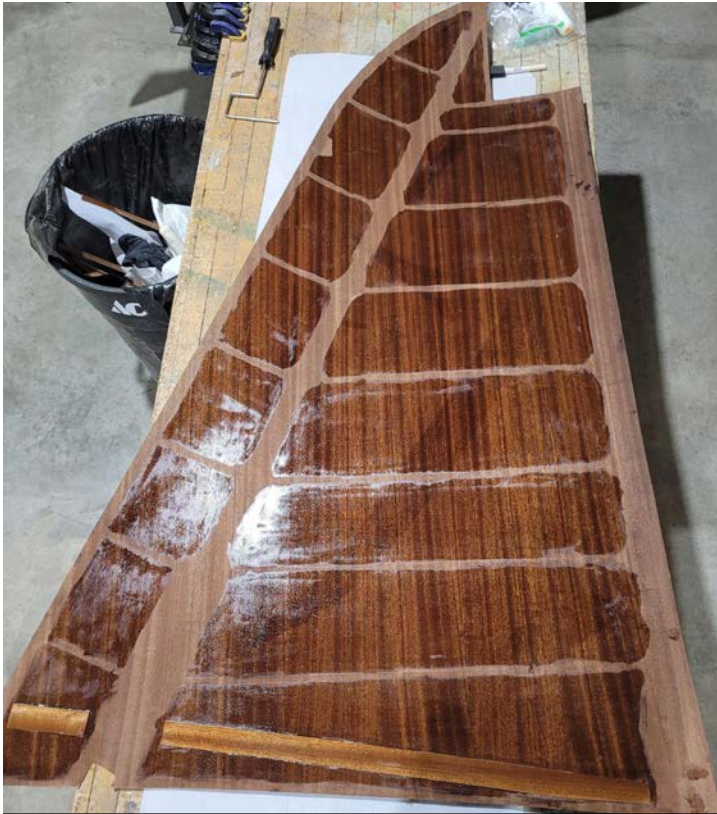
Epoxy coats the areas of the skin that will not have glue applied.

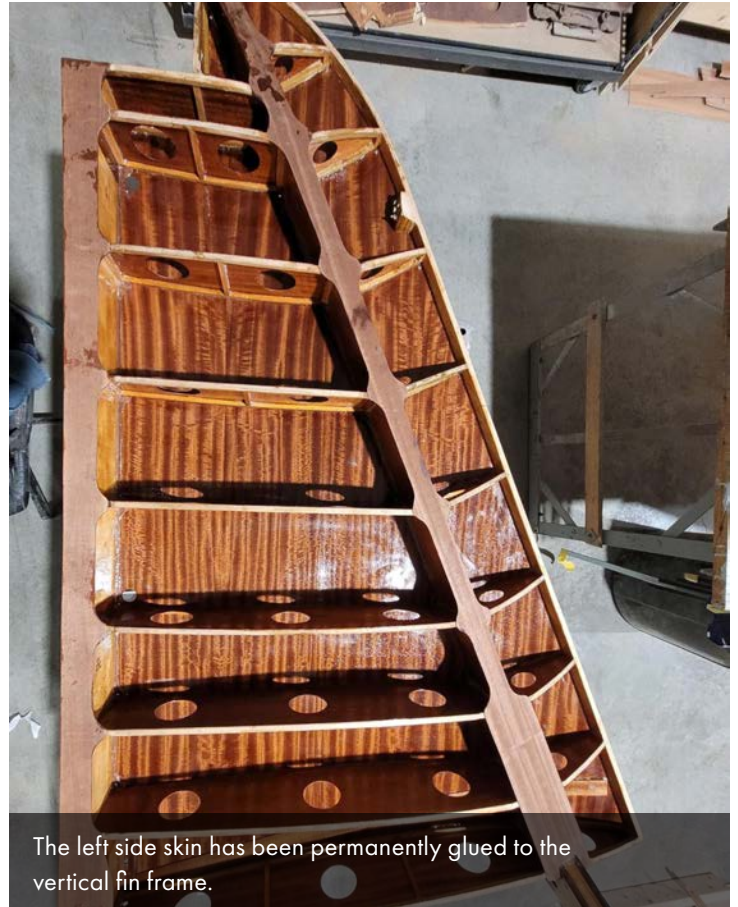
The left side skin has been permanently glued to the vertical fin frame.

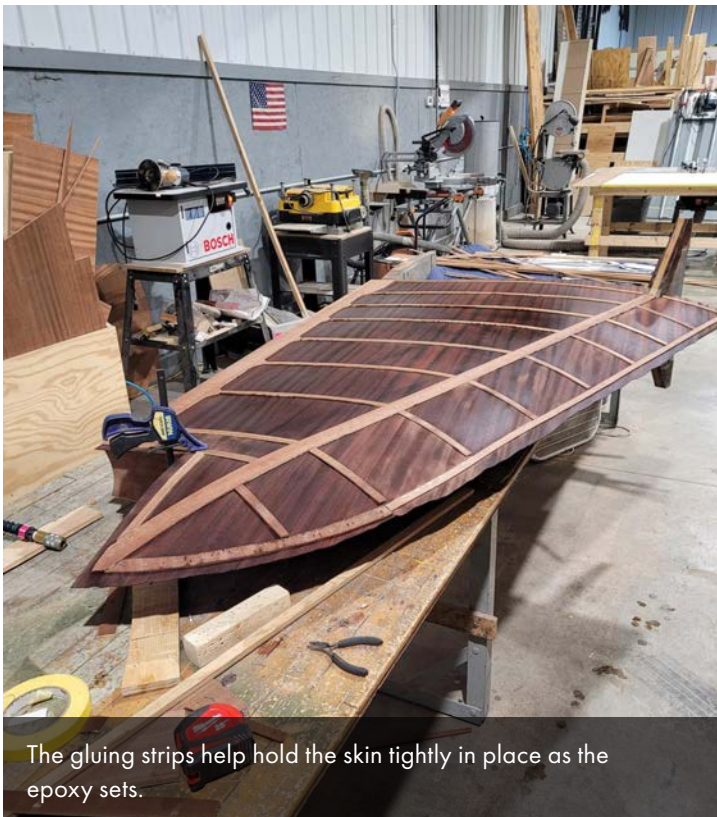
The gluing strips help hold the skin tightly in place as the epoxy sets.

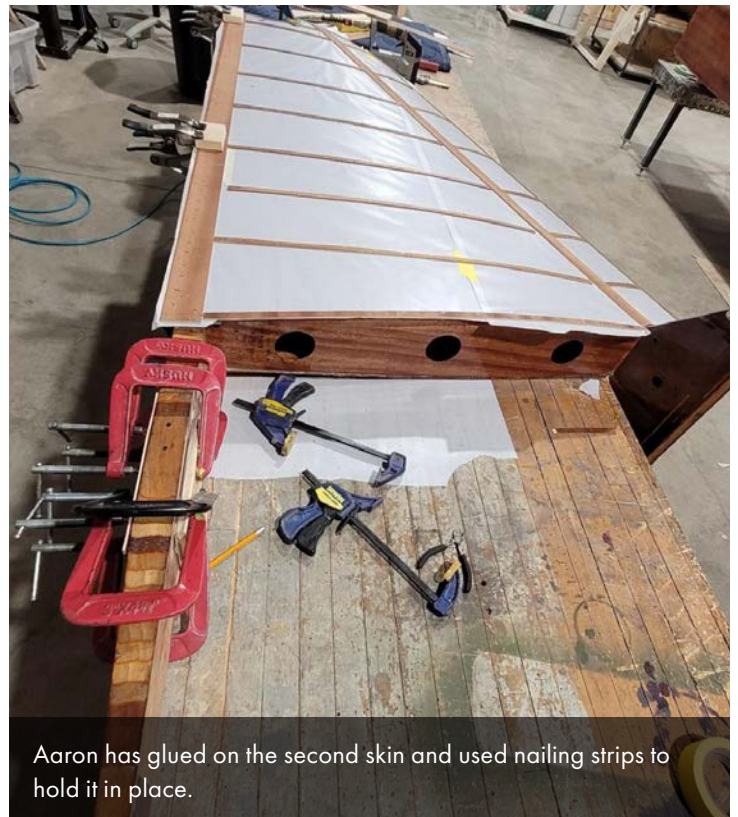
Aaron has glued on the second skin and used nailing strips to hold it in place.
