# AT-10 WICHITA

Cadet Air Corps Museum AT-10 Wichita Restoration

by Chuck Cravens

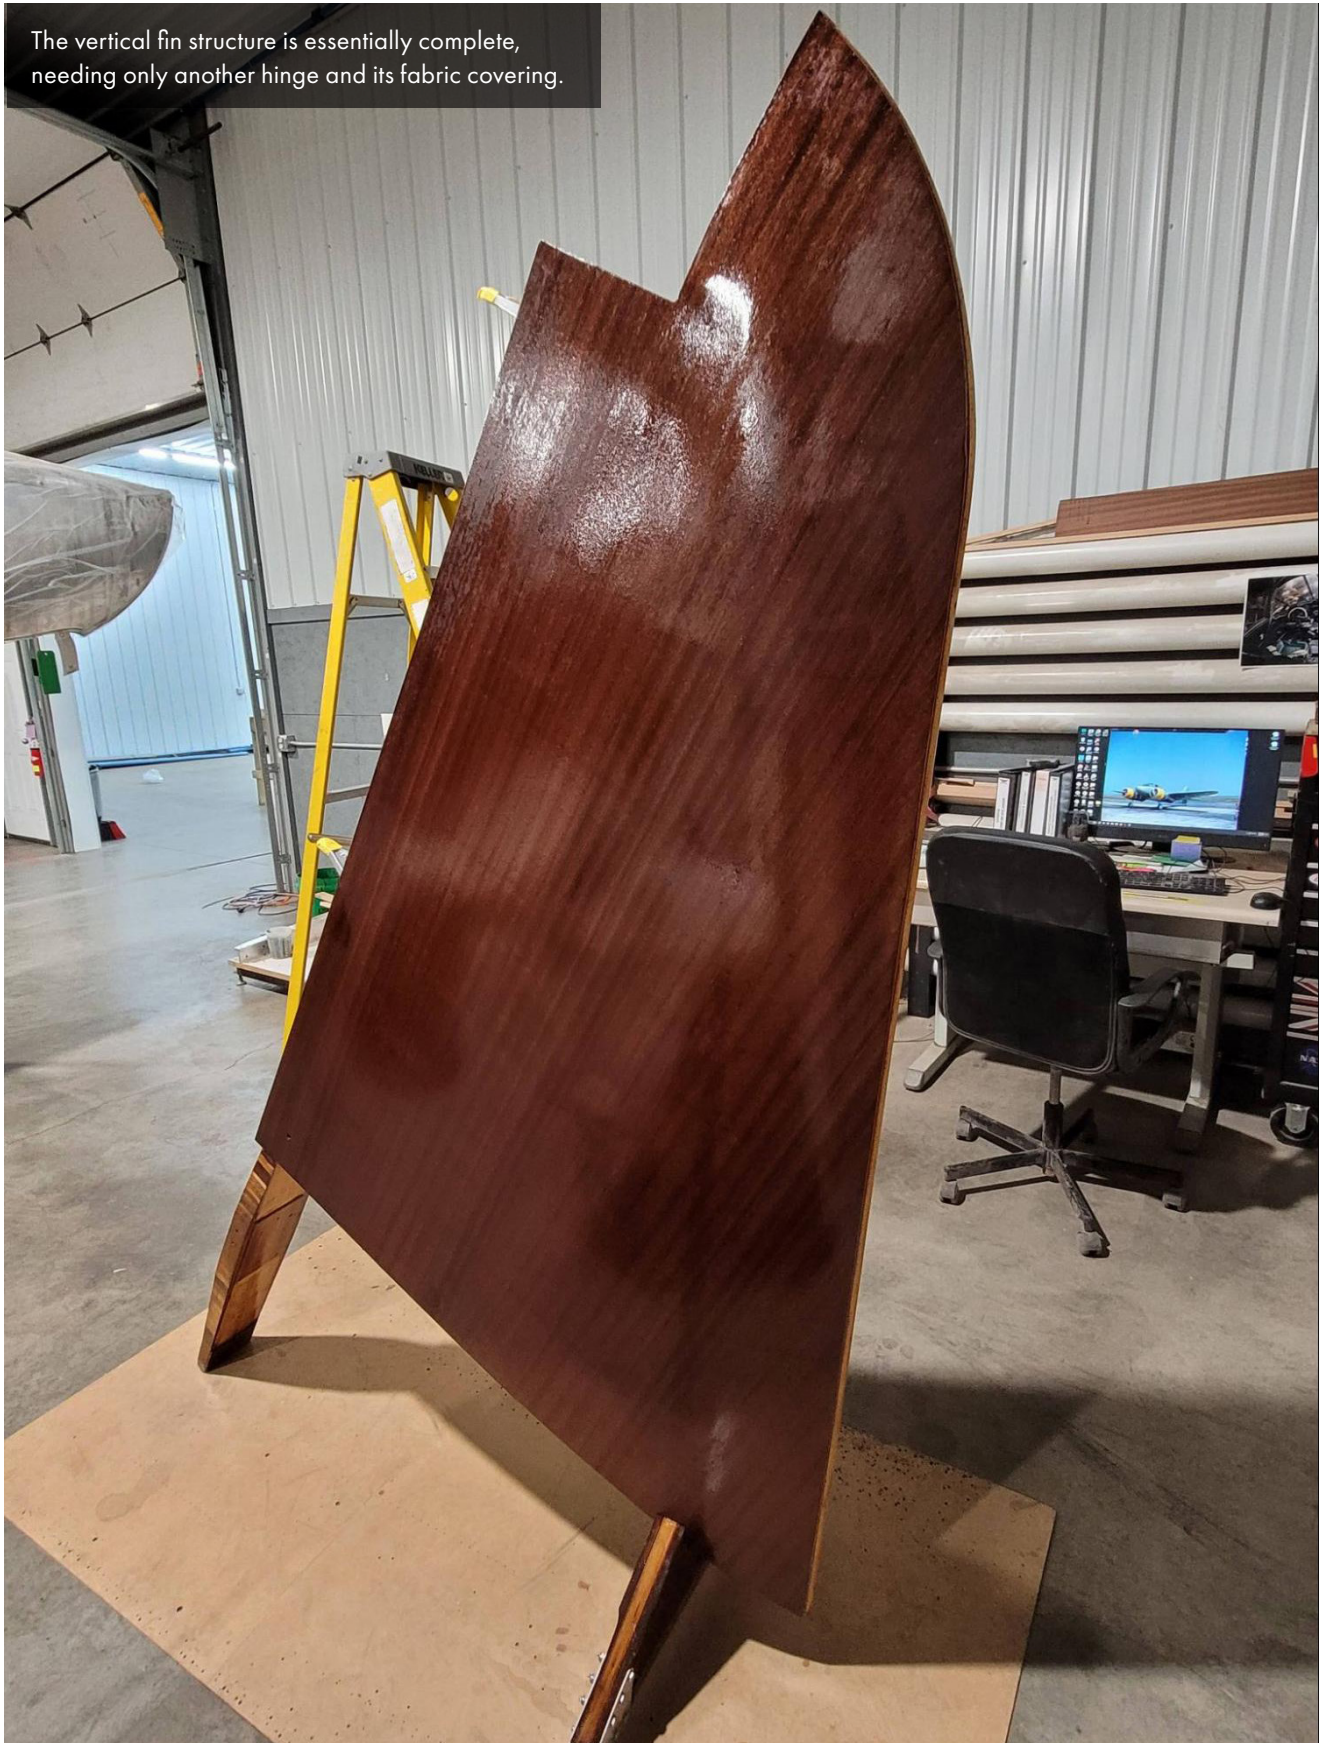
The vertical fin structure is essentially complete, needing only another hinge and its fabric covering.

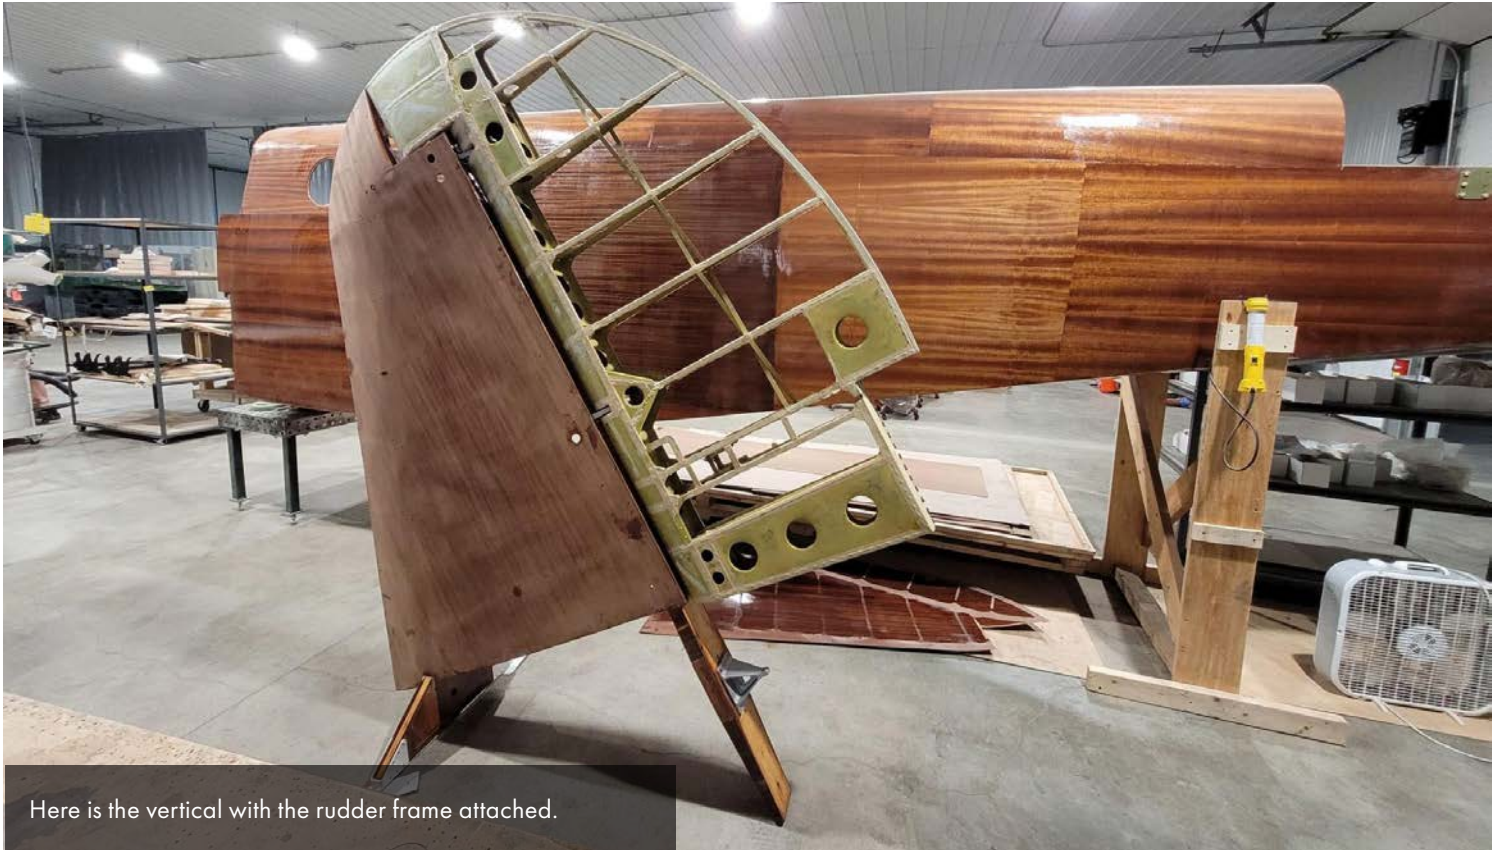
Here is the vertical with the rudder frame attached.

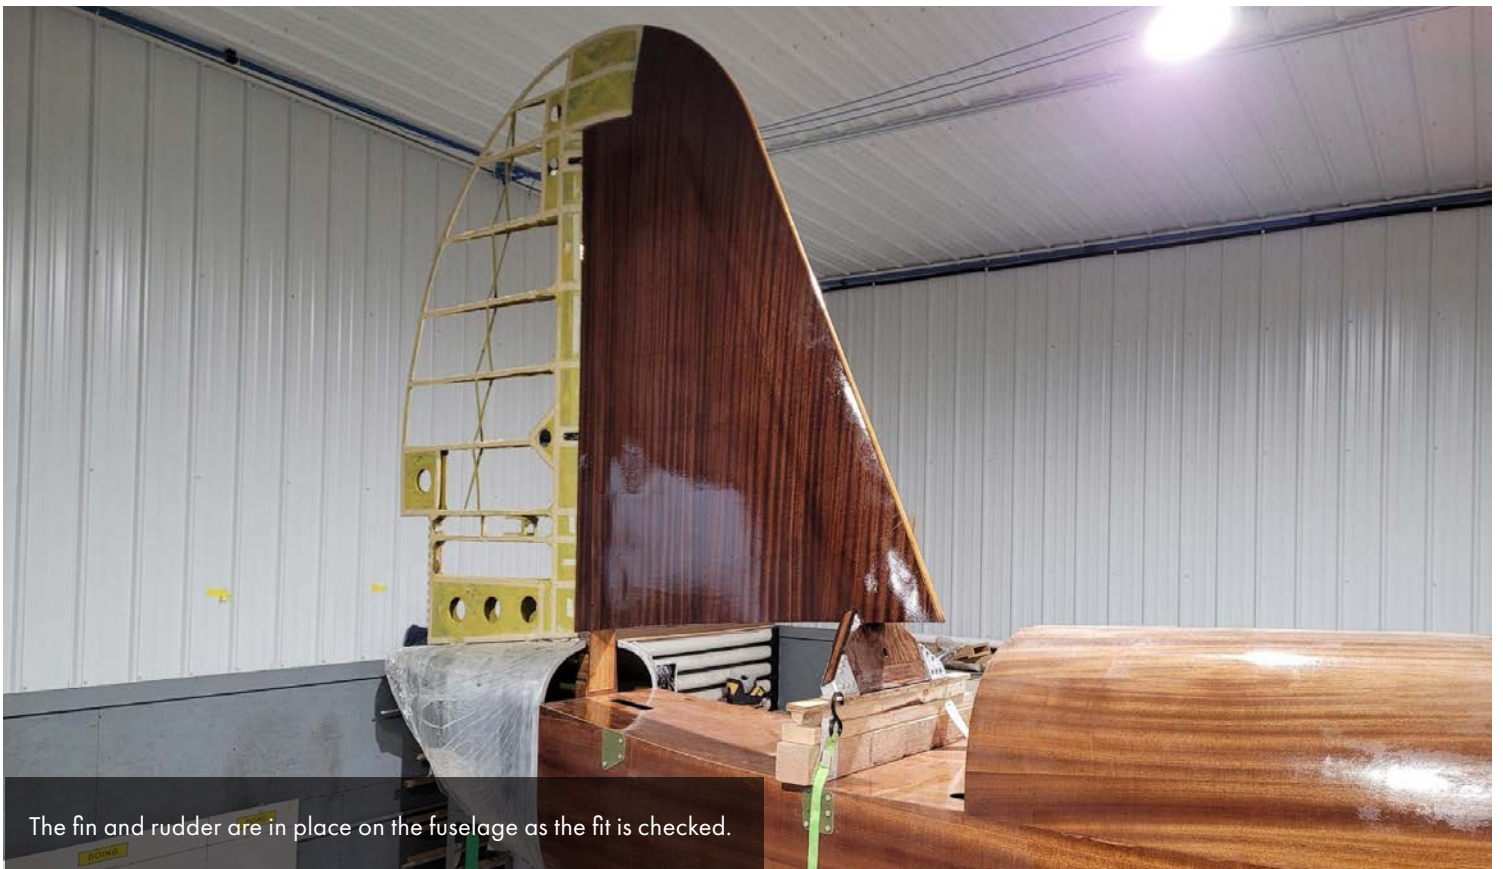
The fin and rudder are in place on the fuselage as the fit is checked.

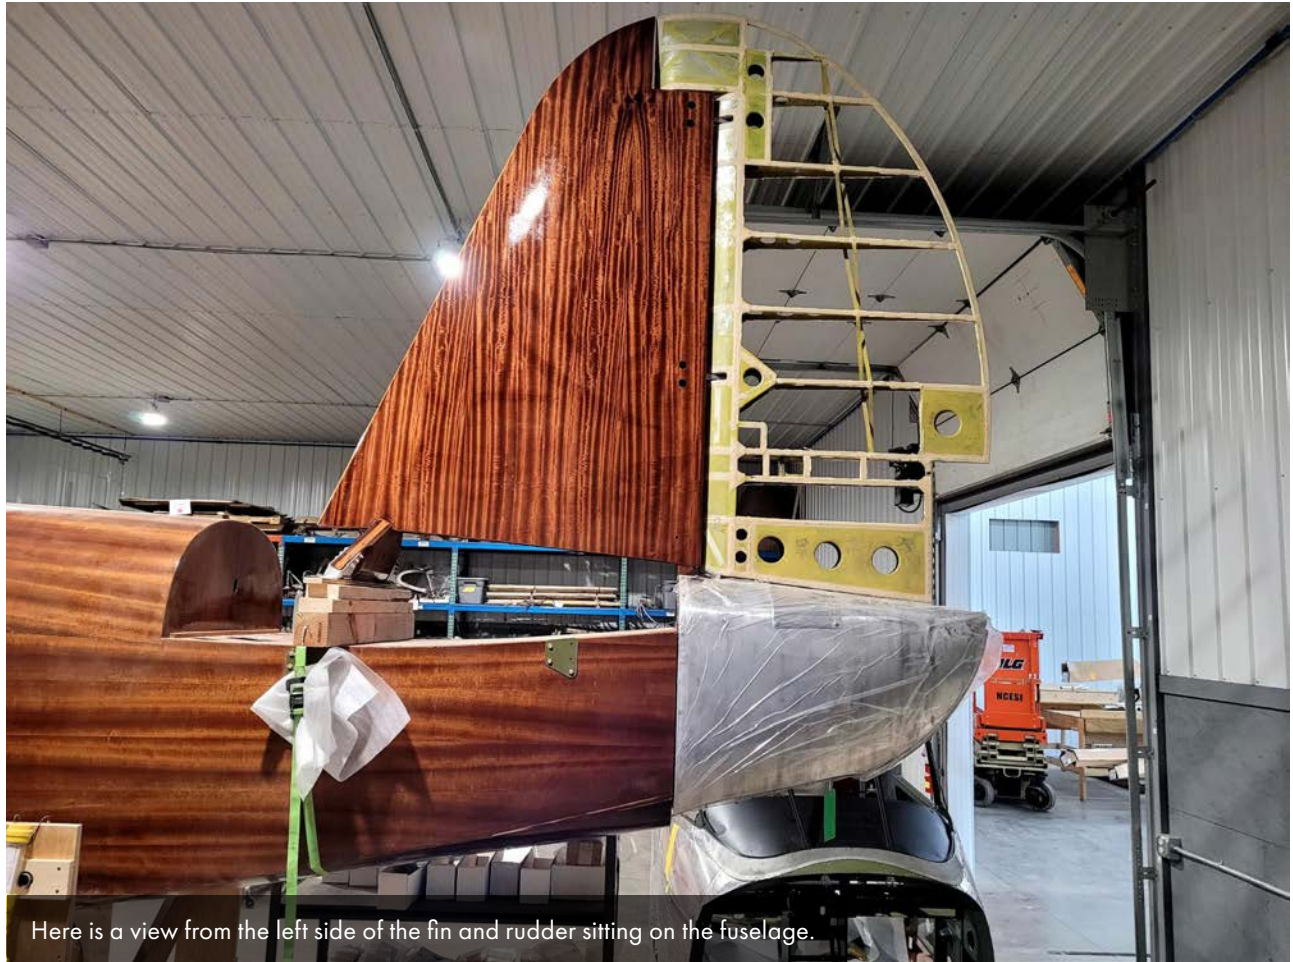
Here is a view from the left side of the fin and rudder sitting on the fuselage.

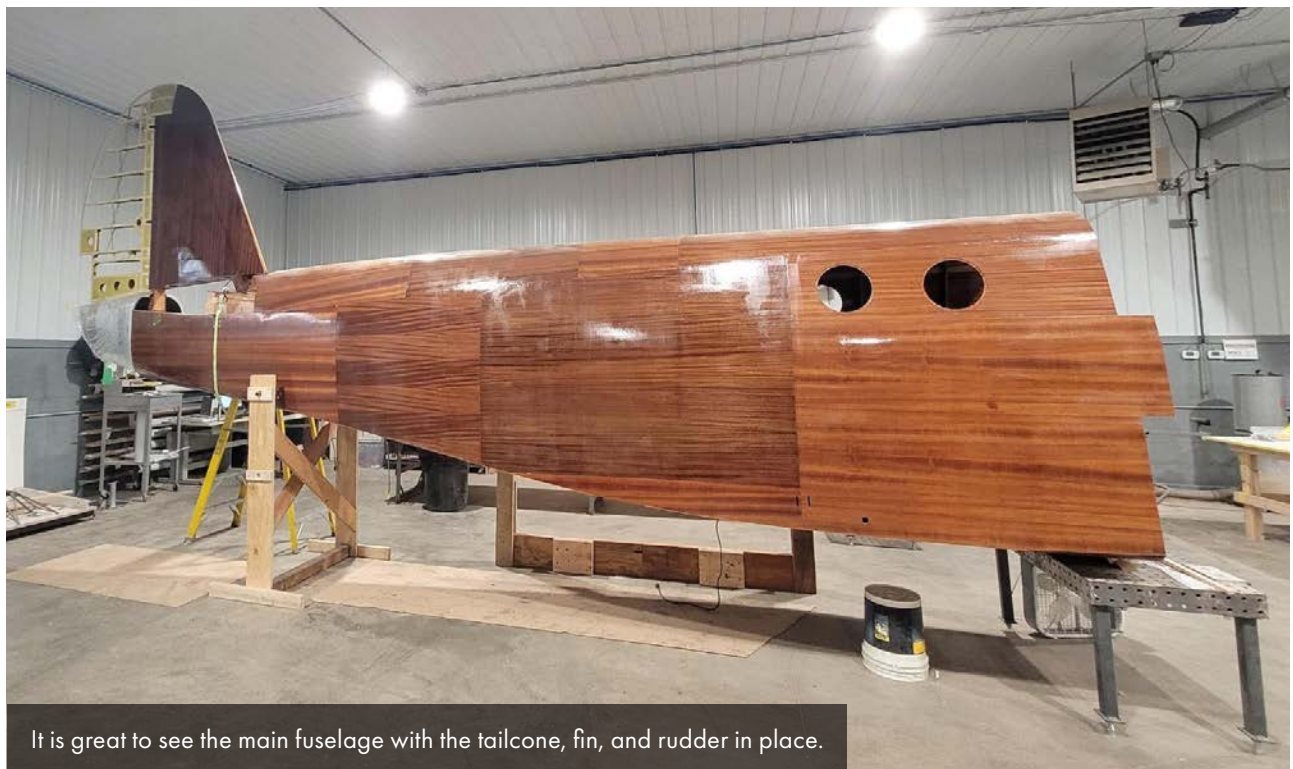
It is great to see the main fuselage with the tailcone, fin, and rudder in place.
