Dakota Territory Air Museum's P-47 Update
by Chuck Cravens

Update

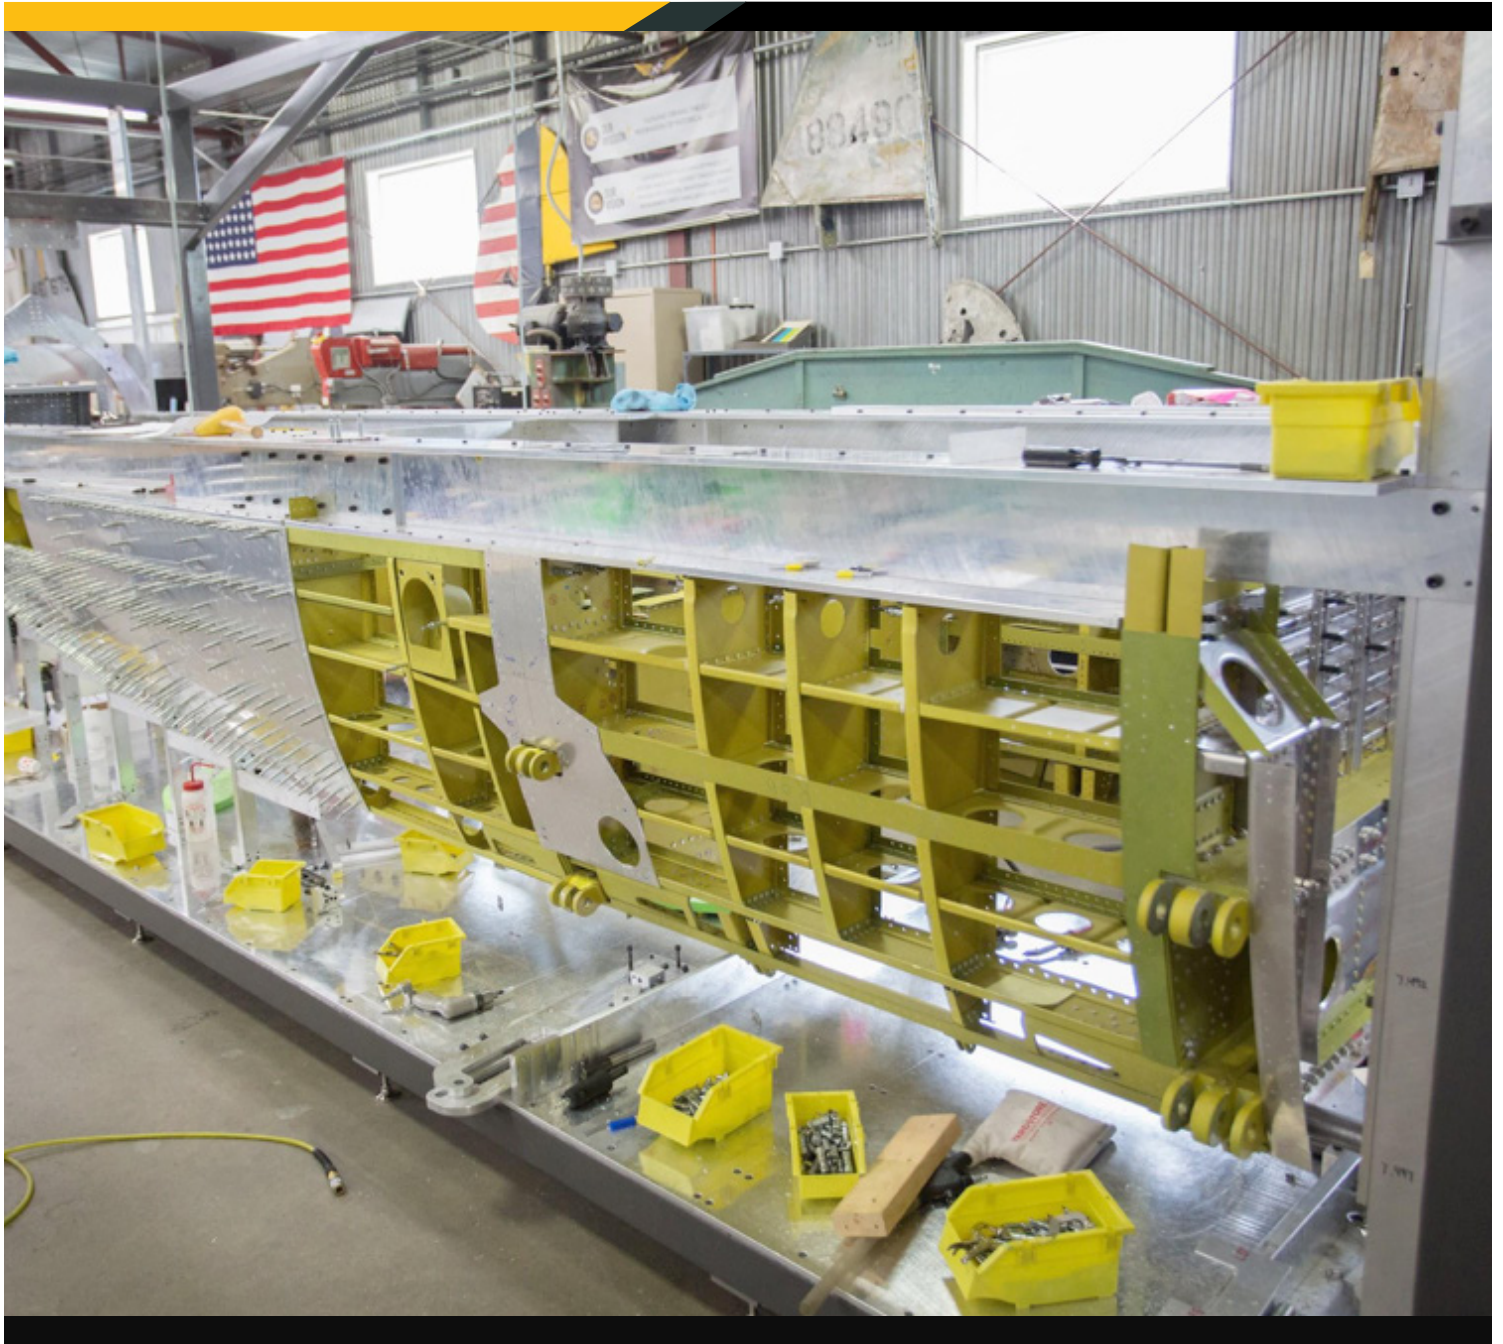
Skin sections are going on the P-47 forward fuselage.

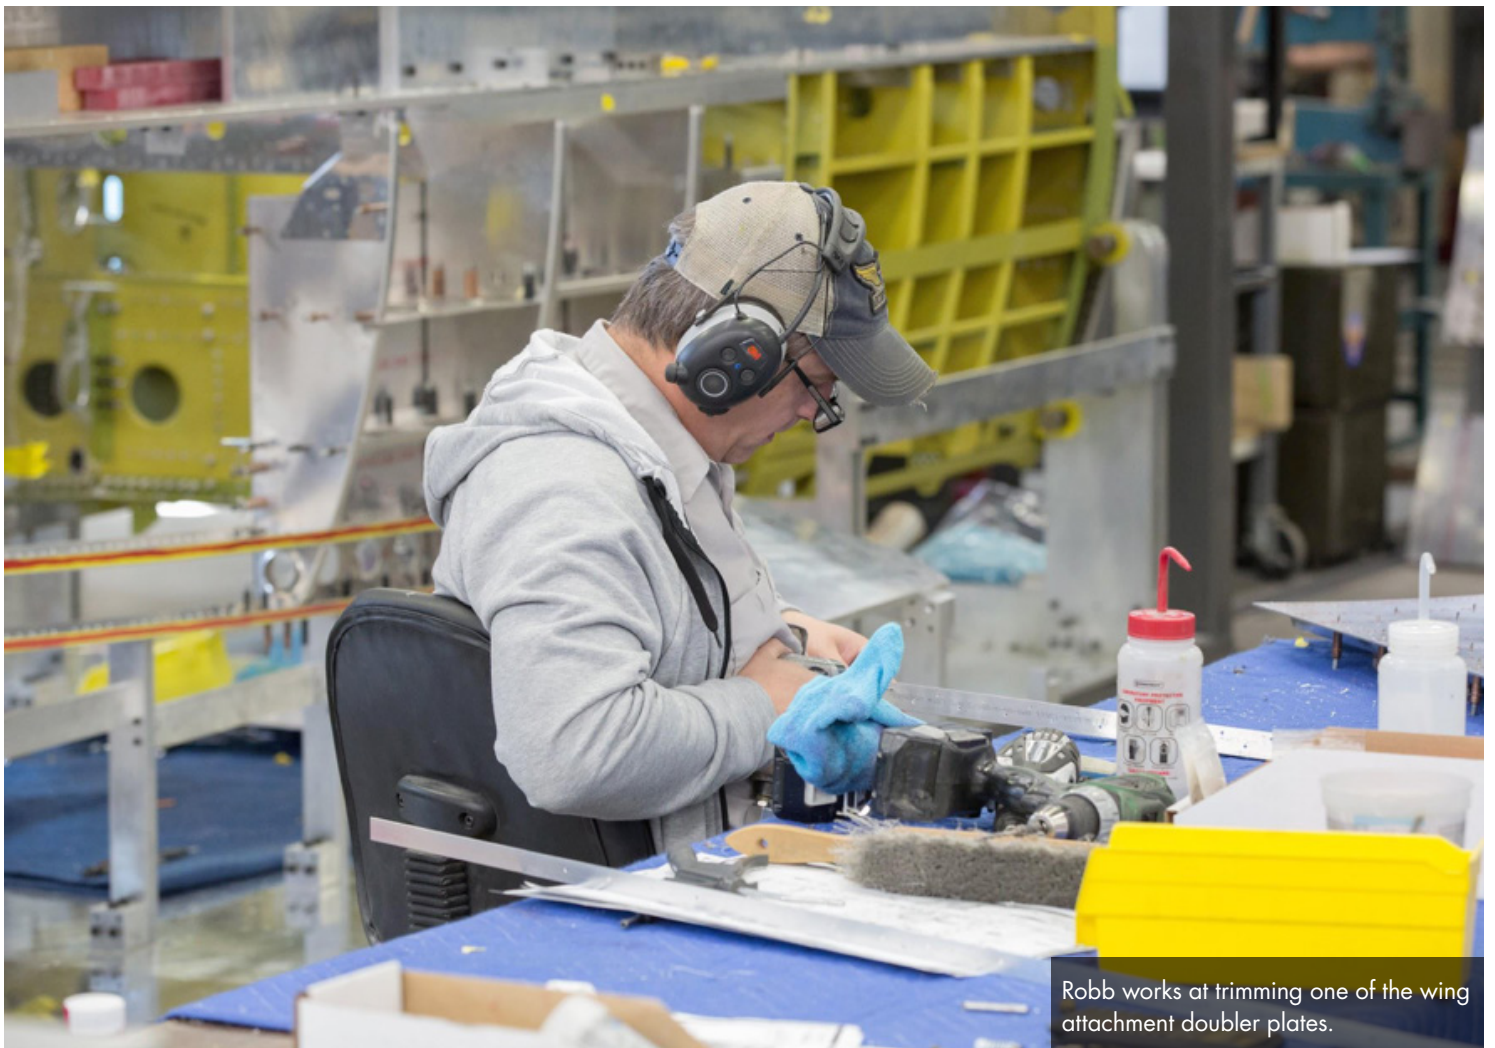
Robb works at trimming one of the wing attachment doubler plates.

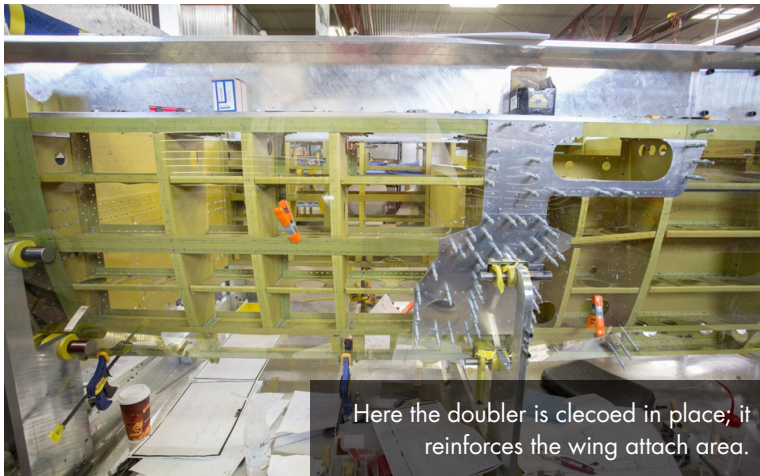
Here the doubler is clecoed in place; it reinforces the wing attach area.

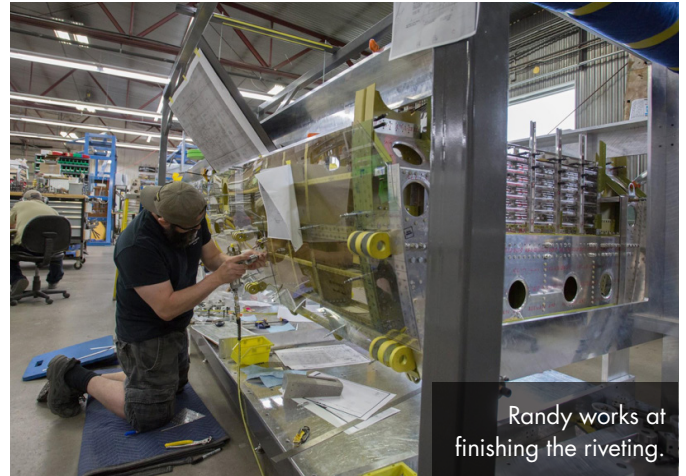
Randy works at finishing the riveting.

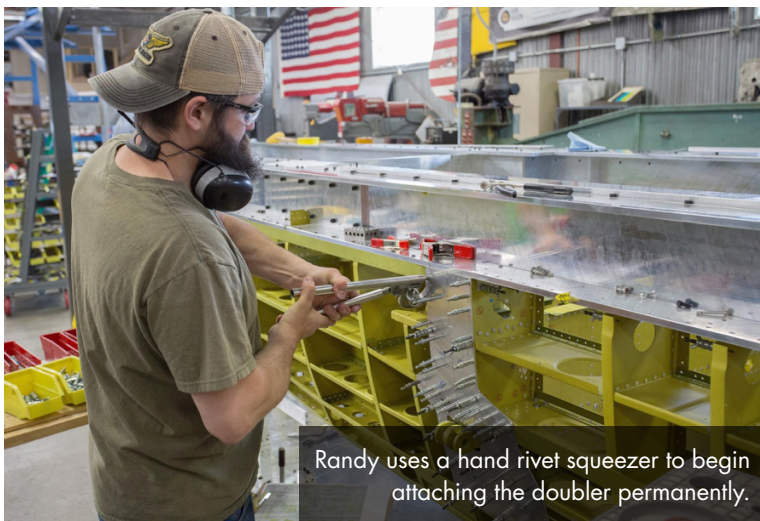
Randy uses a hand rivet squeezer to begin attaching the doubler permanently.

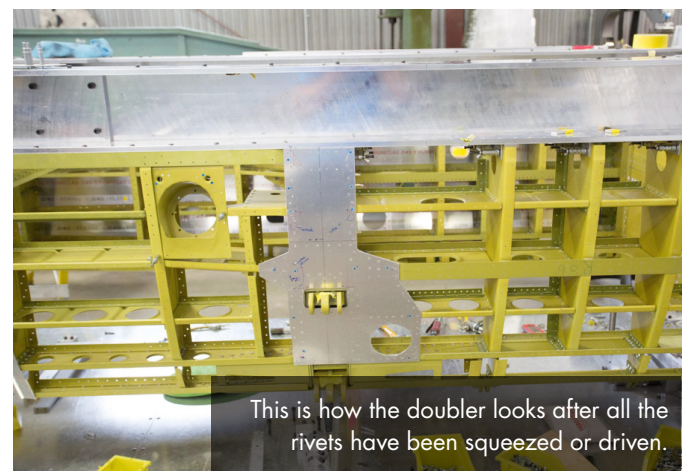
This is how the doubler looks after all the rivets have been squeezed or driven.

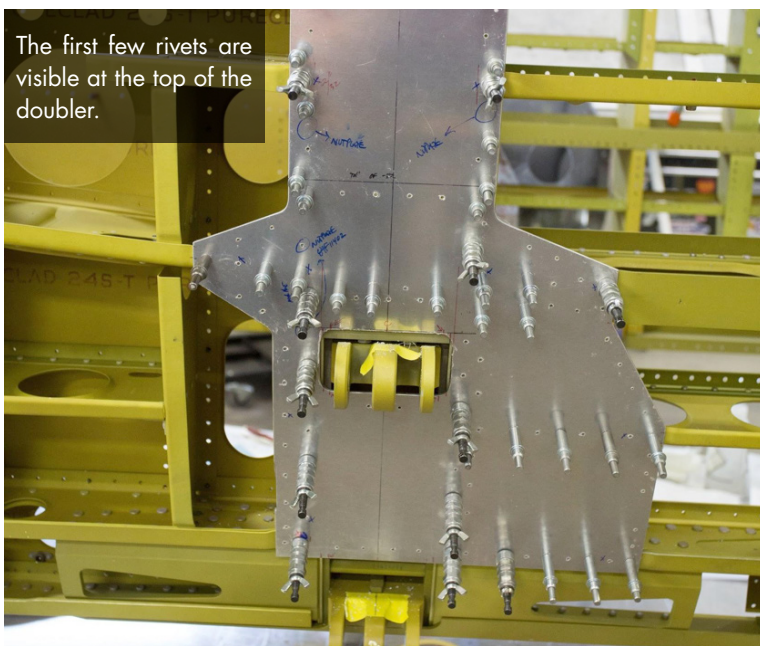
The first few rivets are visible at the top of the doubler.

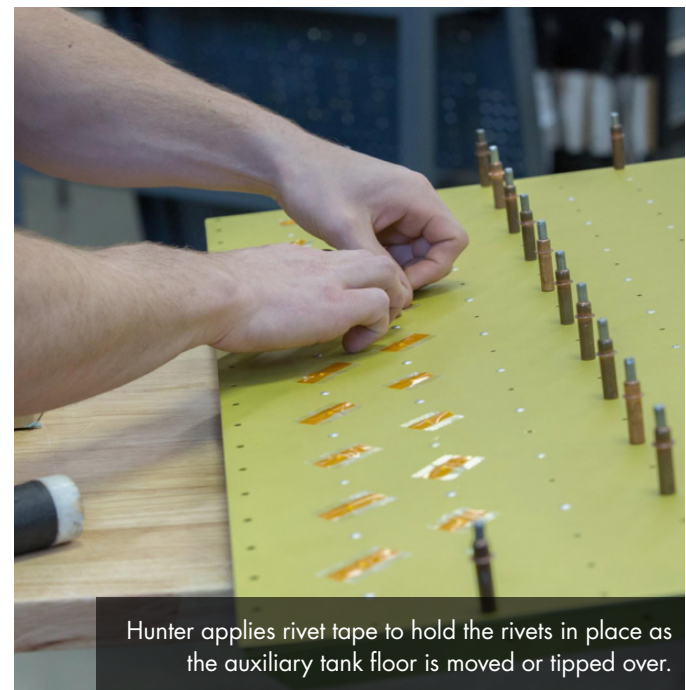
Hunter applies rivet tape to hold the rivets in place as the auxiliary tank floor is moved or tipped over.

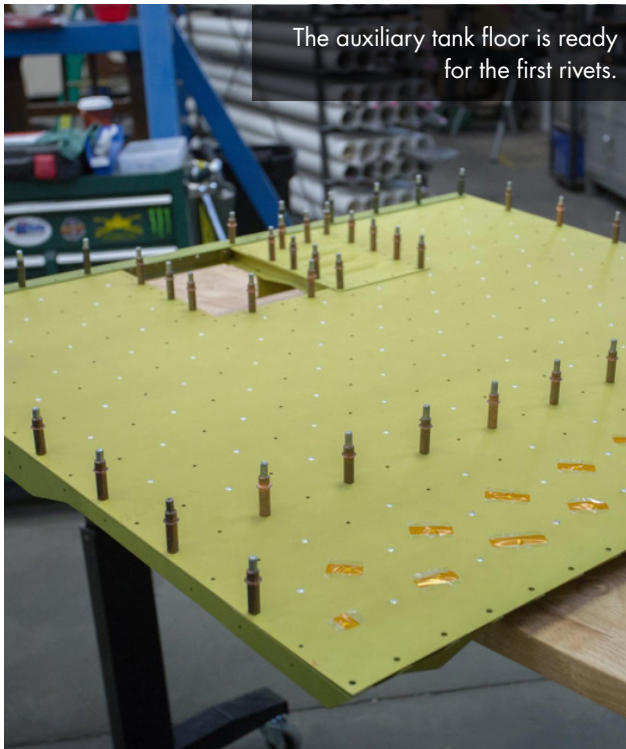
The auxiliary tank floor is ready for the first rivets.

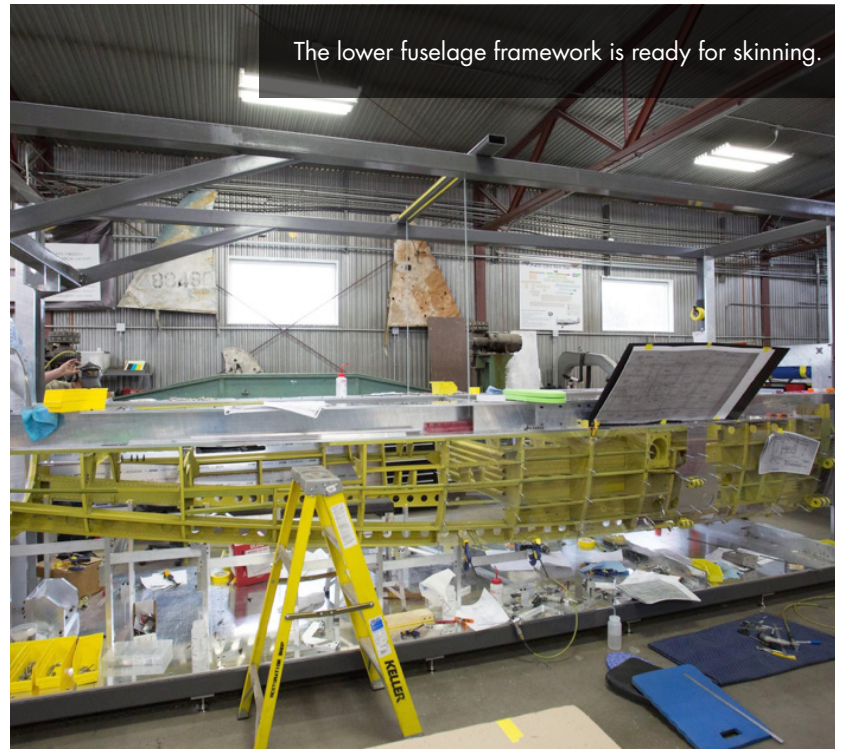
The lower fuselage framework is ready for skinning.

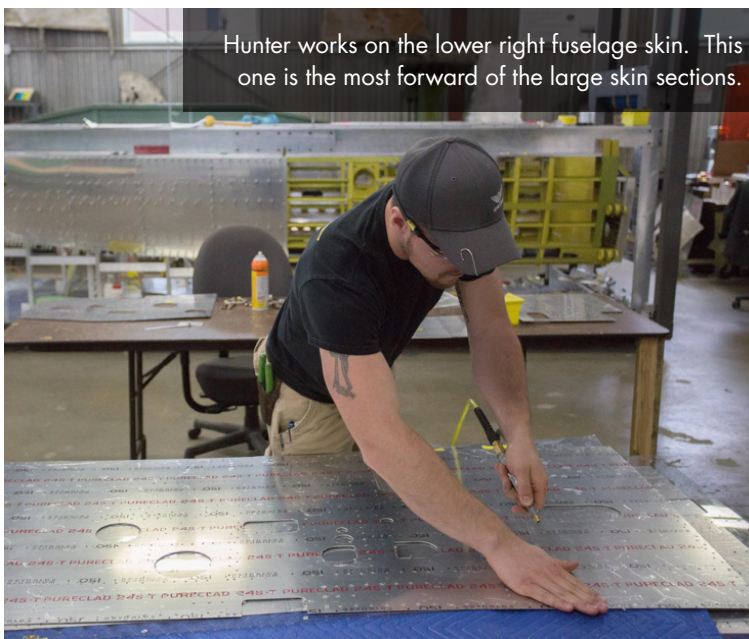
Hunter works on the lower right fuselage skin. This one is the most forward of the large skin sections.

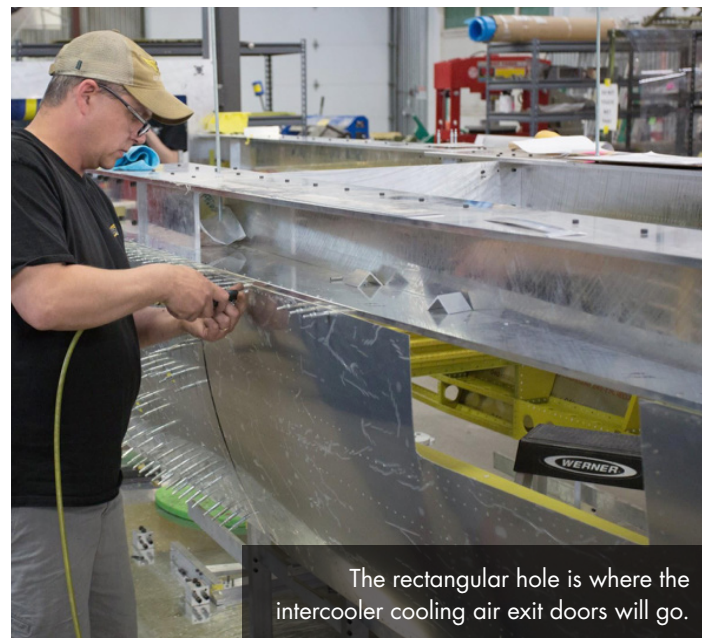
The rectangular hole is where the intercooler cooling air exit doors will go.

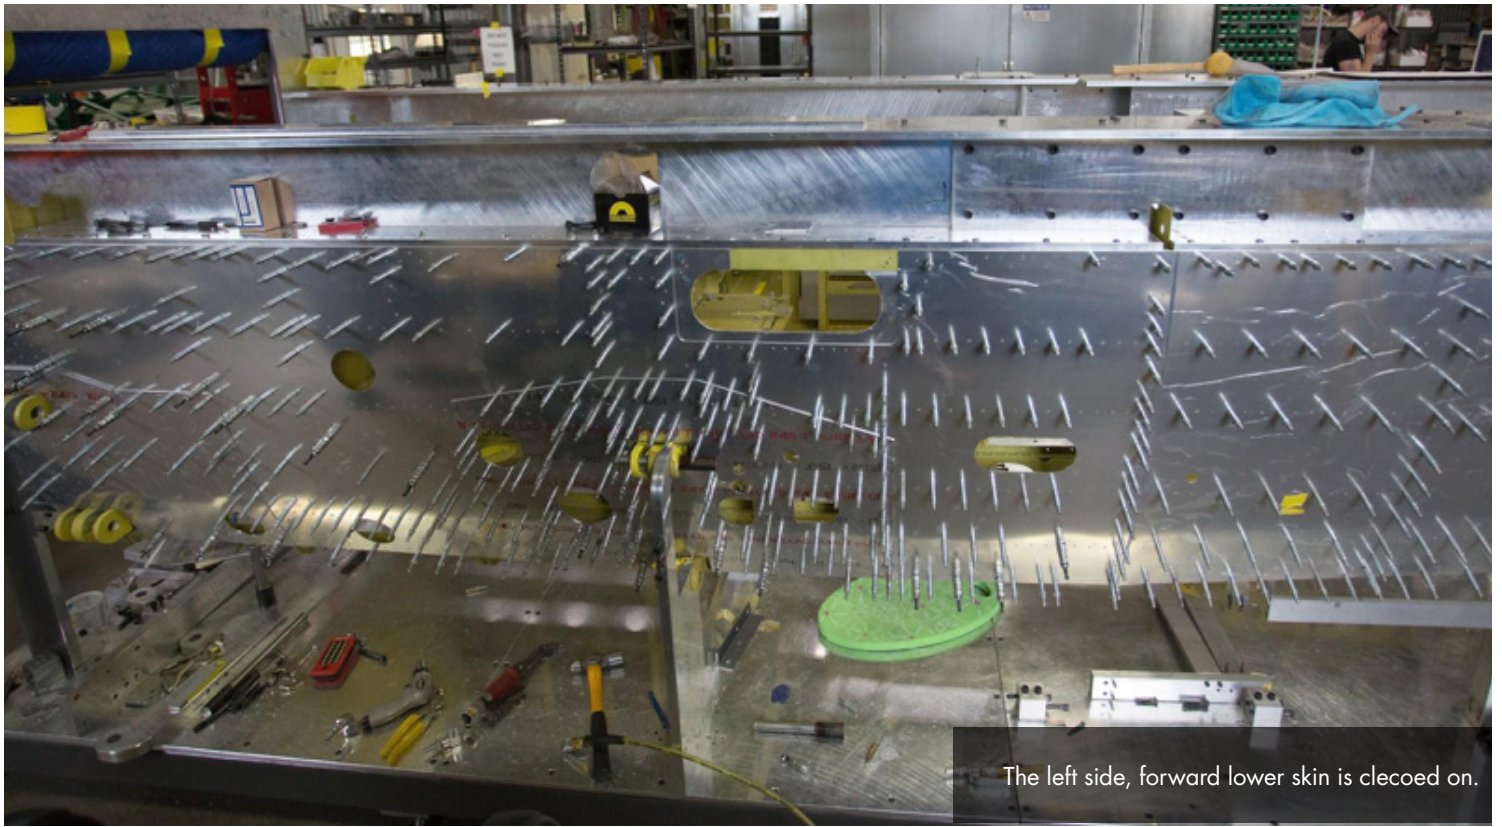
The left side, forward lower skin is clecoed on.

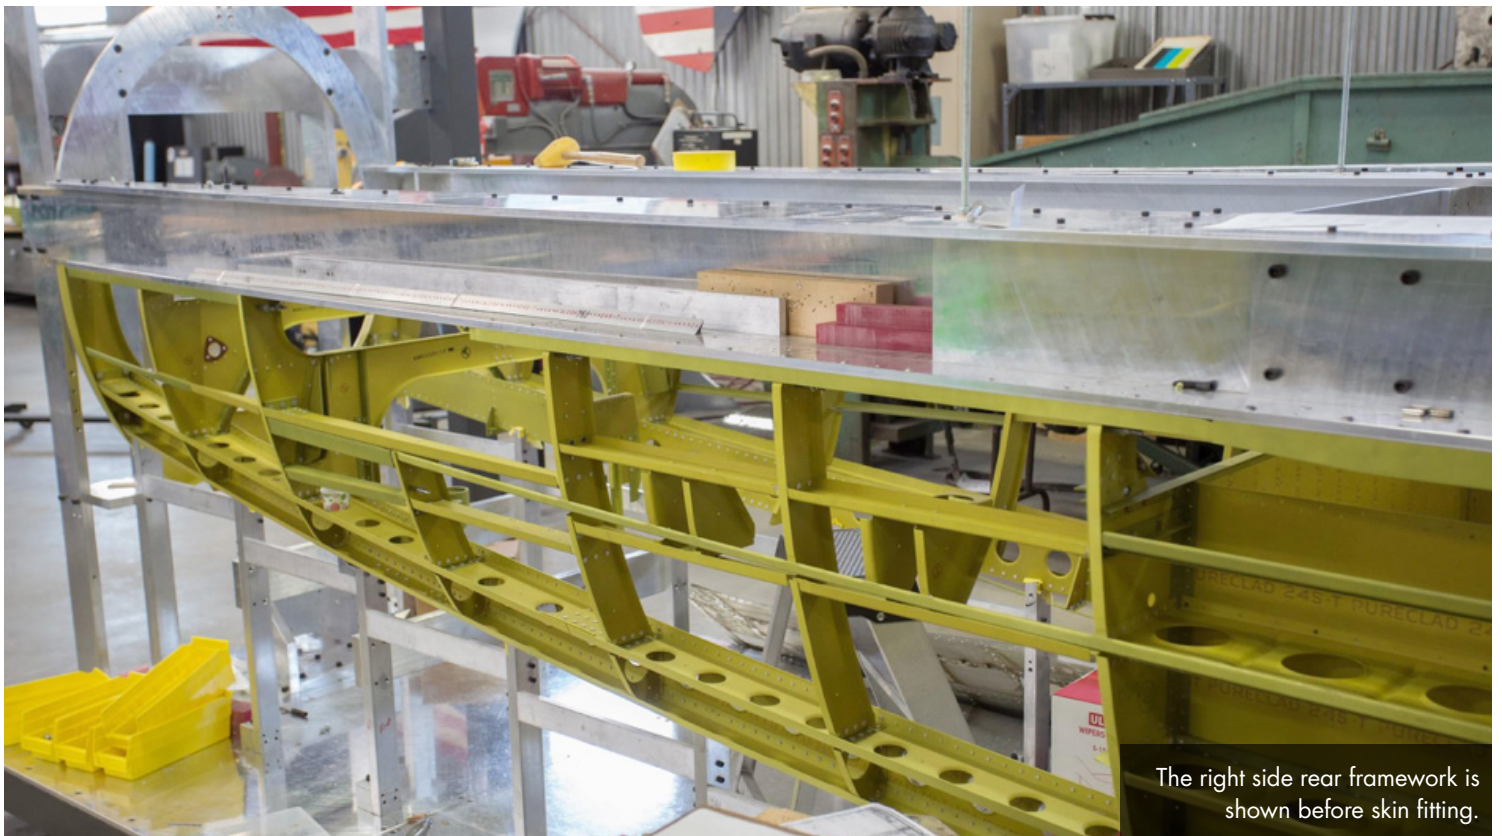
The right side rear framework is shown before skin fitting.

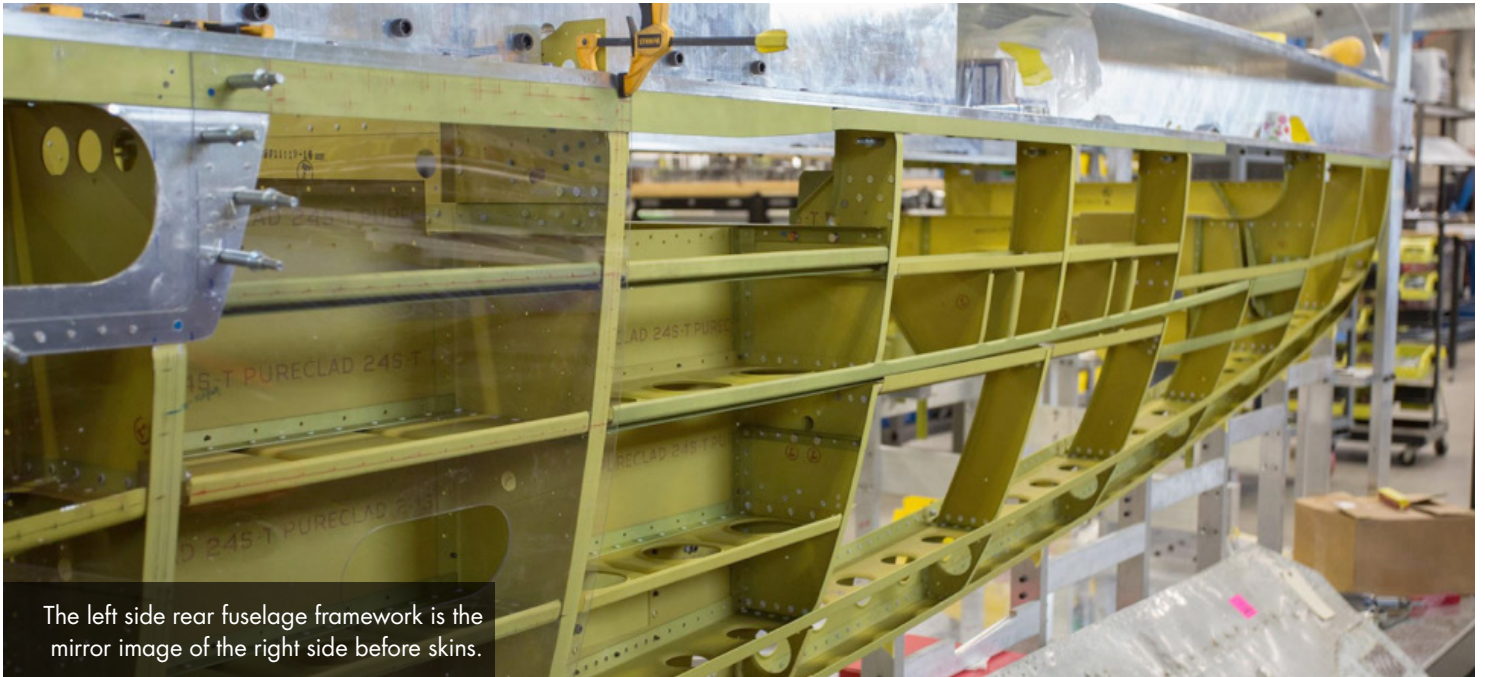
The left side rear fuselage framework is the mirror image of the right side before skins.

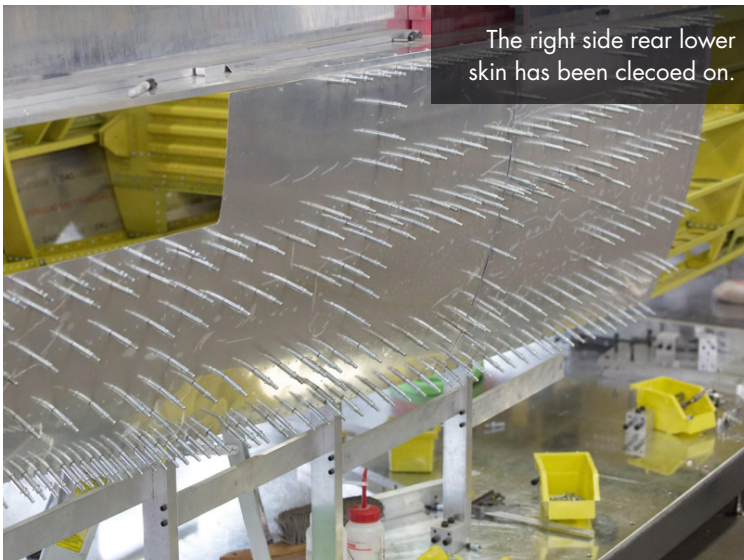
The right side rear lower skin has been clecoed on.

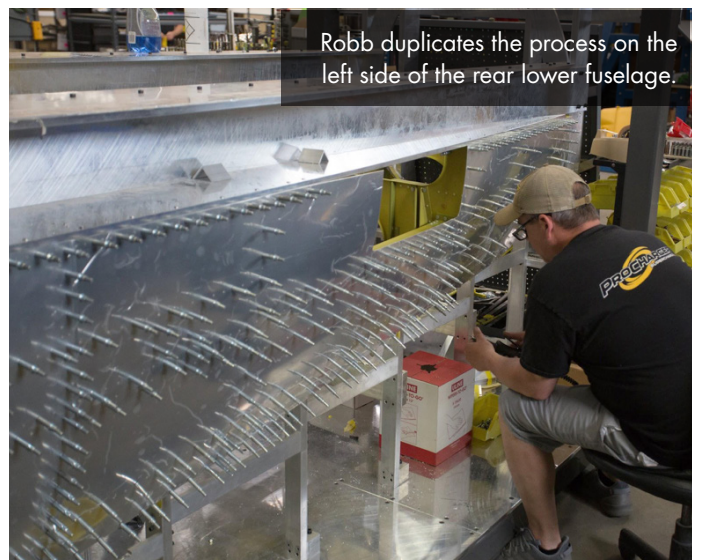
Robb duplicates the process on the left side of the rear lower fuselage.

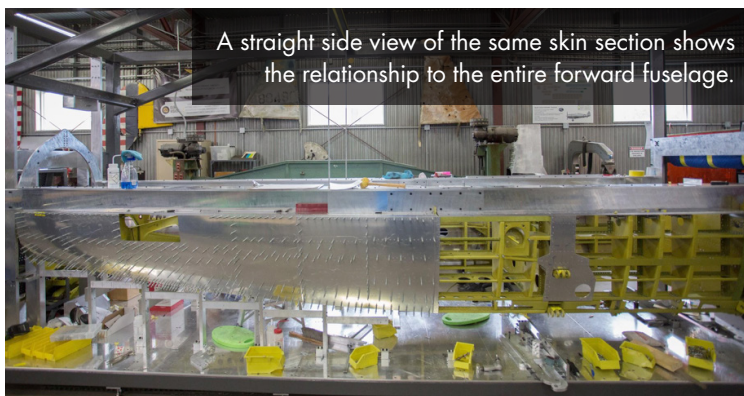
A straight side view of the same skin section shows the relationship to the entire forward fuselage.

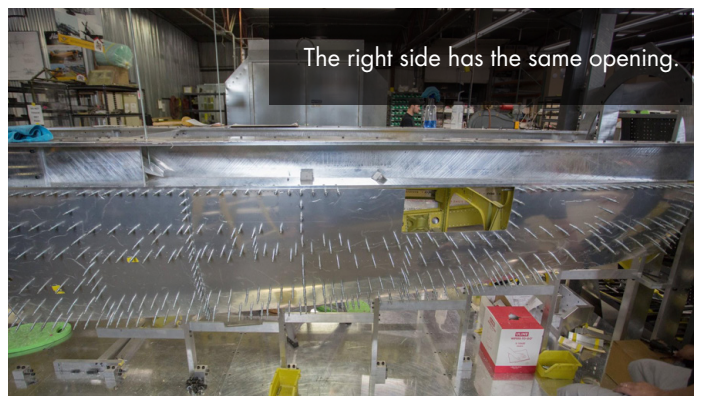
The right side has the same opening.

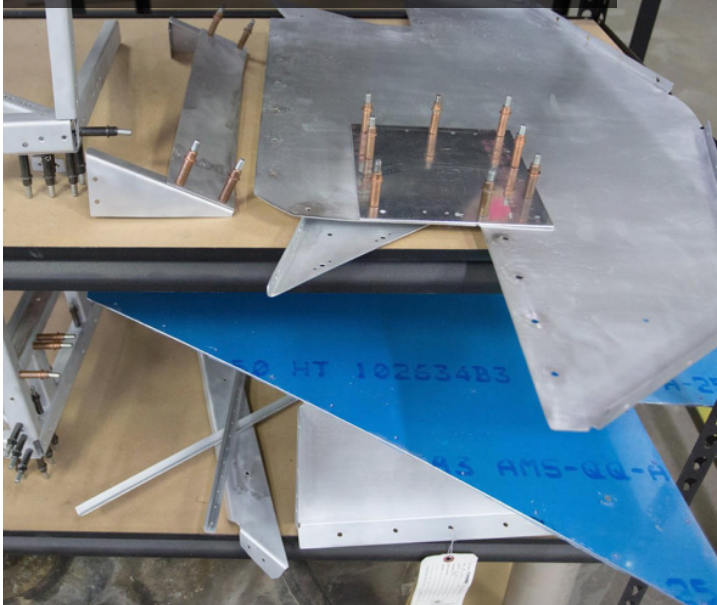
Christmas tree tank parts await assembly on a shelf. The Christmas tree tank is a unique feature of this P-47; they were installed in some P-47s in the SW Pacific theater in an attempt to increase the P-47's range.

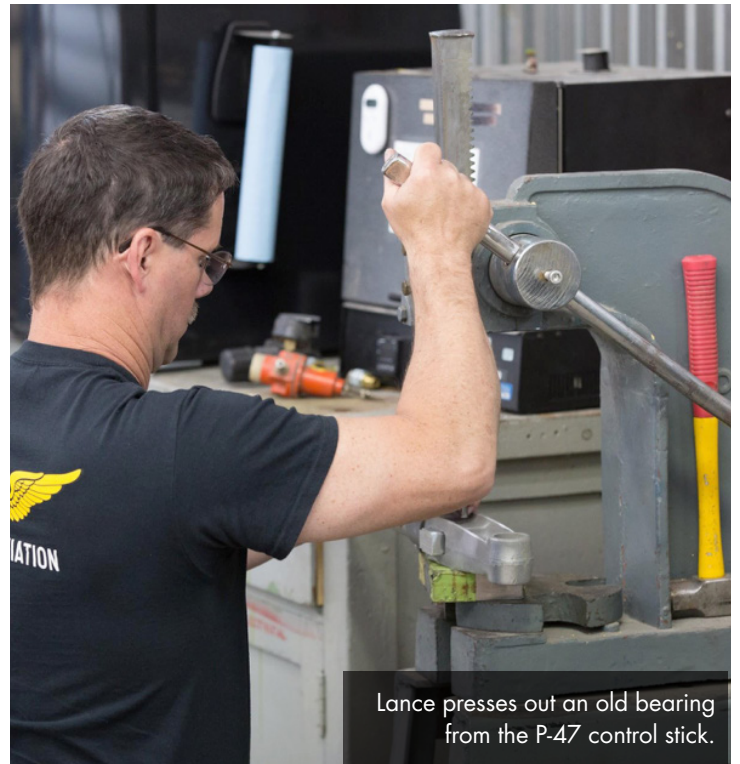
Lance presses out an old bearing from the P-47 control stick.

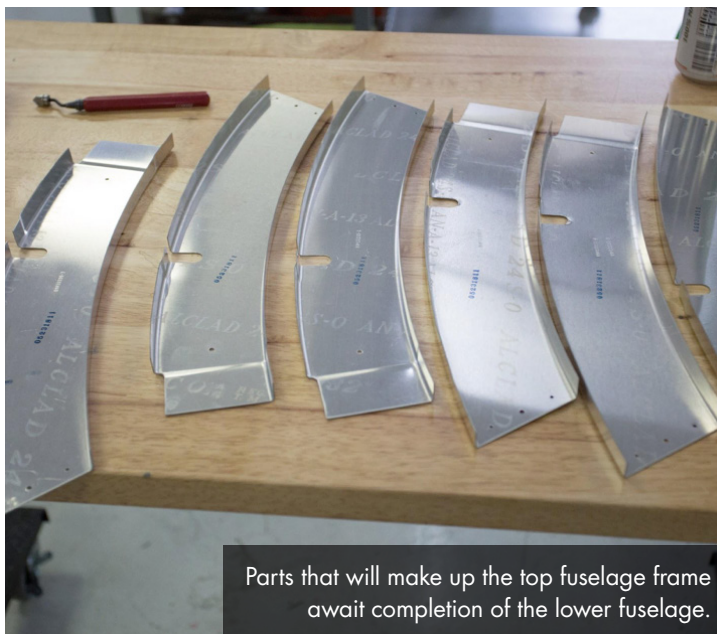
Parts that will make up the top fuselage frame await completion of the lower fuselage.

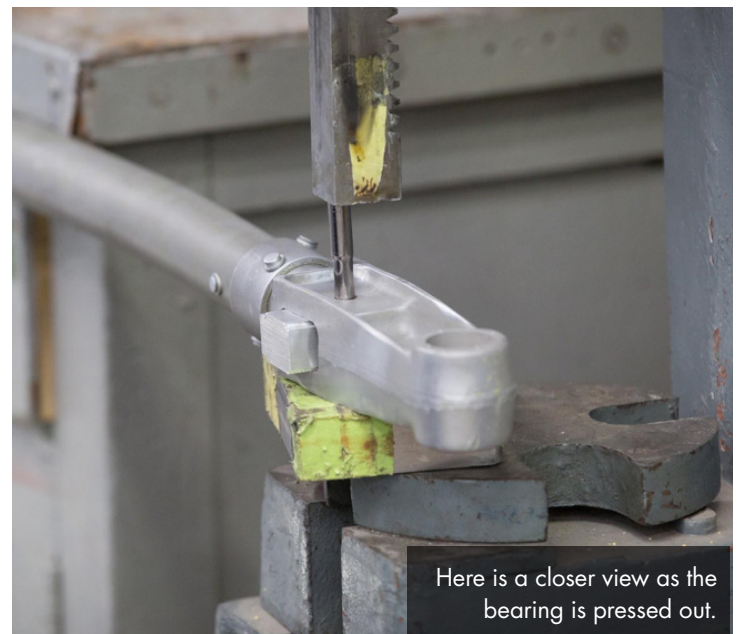
Here is a closer view as the bearing is pressed out.

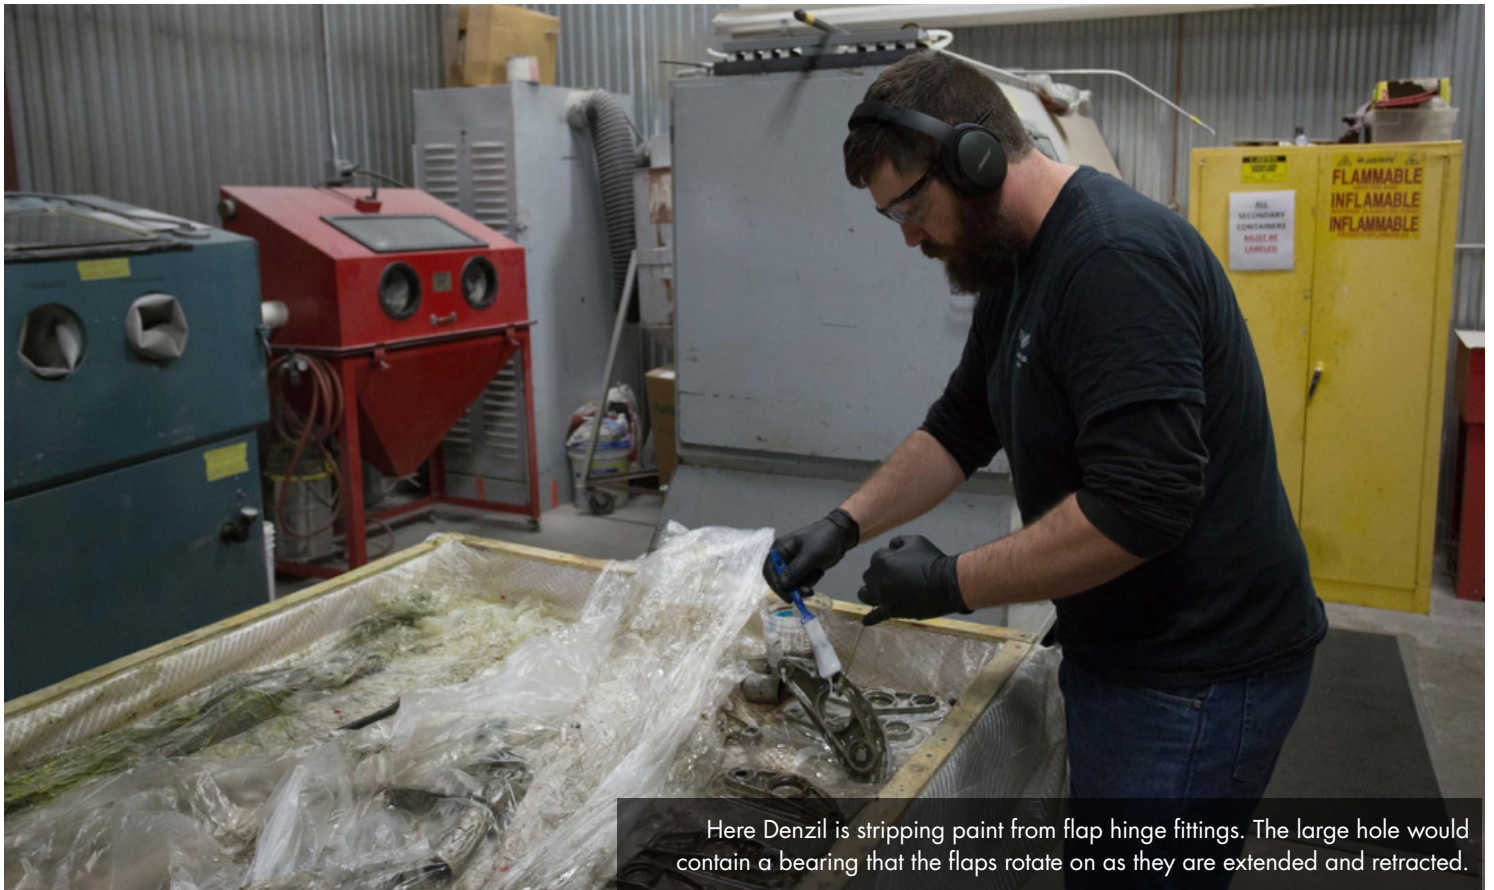
Here Denzil is stripping paint from flap hinge fittings. The large hole would contain a bearing that the flaps rotate on as they are extended and retracted.

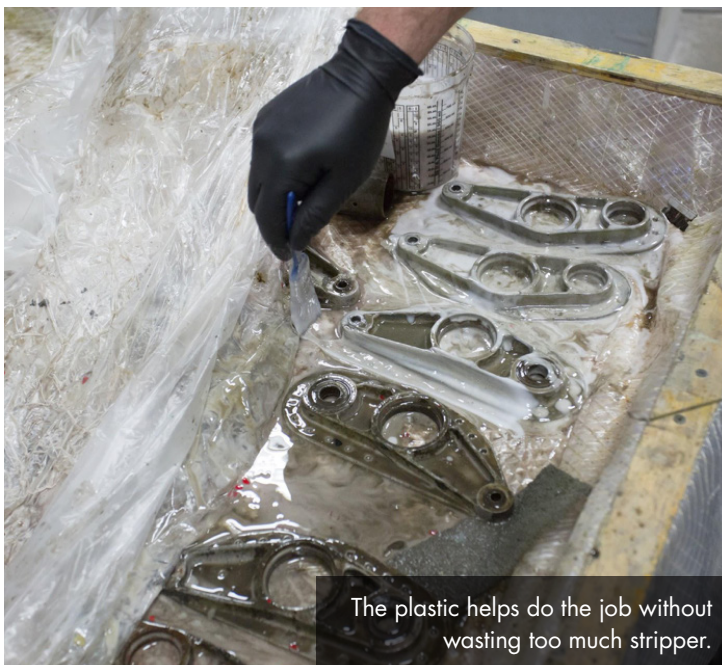
The plastic helps do the job without wasting too much stripper.

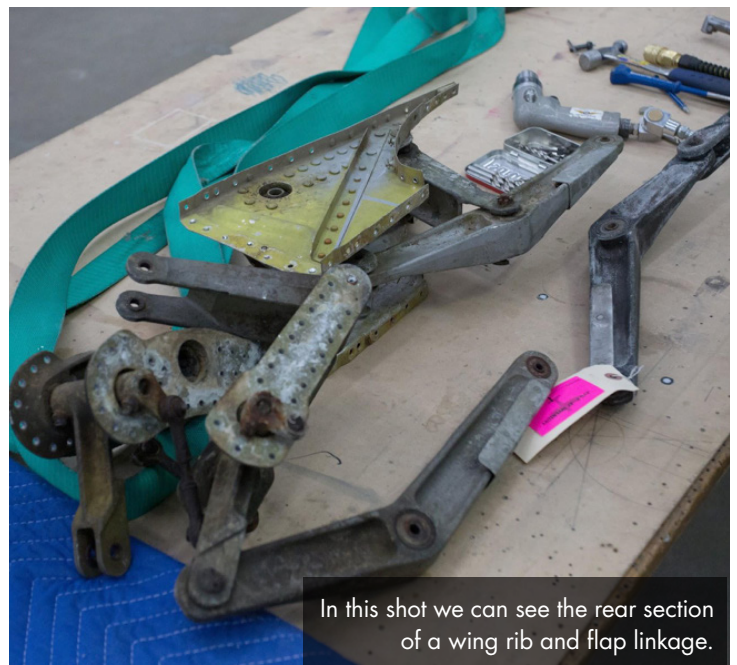
In this shot we can see the rear section of a wing rib and flap linkage.

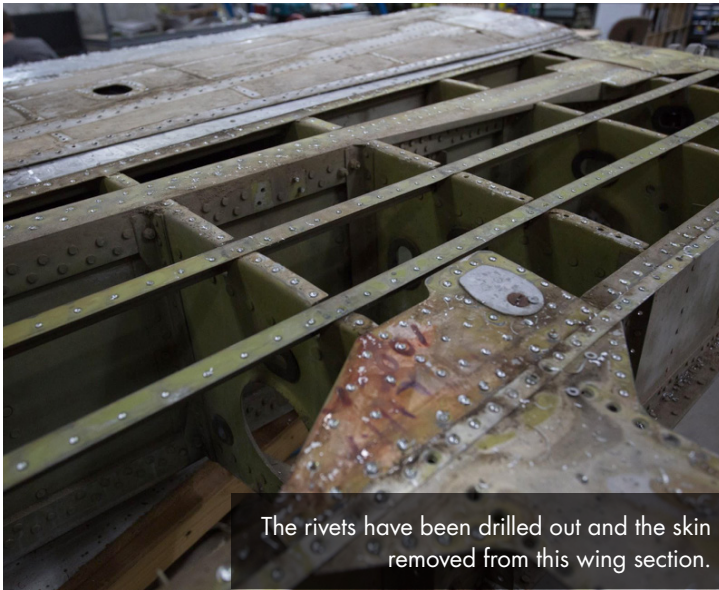
The rivets have been drilled out and the skin removed from this wing section.

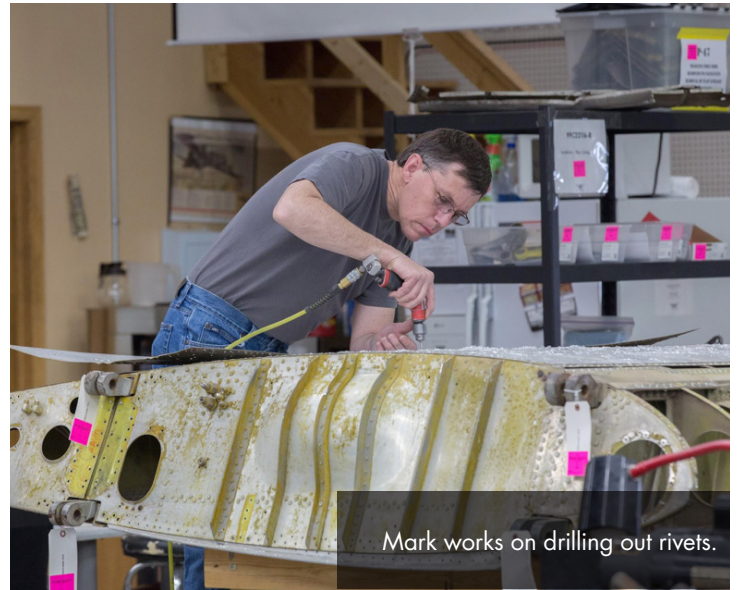
Mark works on drilling out rivets.
